**Re: Hazardous Building Materials Assessment (Pre-construction)**  
Roof Sections A, B, C, D, and E and Specified Interior Areas  
Courtice Secondary School, 1717 Nash Road, Courtice, Ontario  
Pinchin File: 348218.007

Kawartha Pine Ridge District School Board (KPRDSB) (Client) retained Pinchin Ltd. (Pinchin) to conduct a hazardous building materials assessment of Courtice Secondary School located at 1717 Nash Road, Courtice, Ontario.

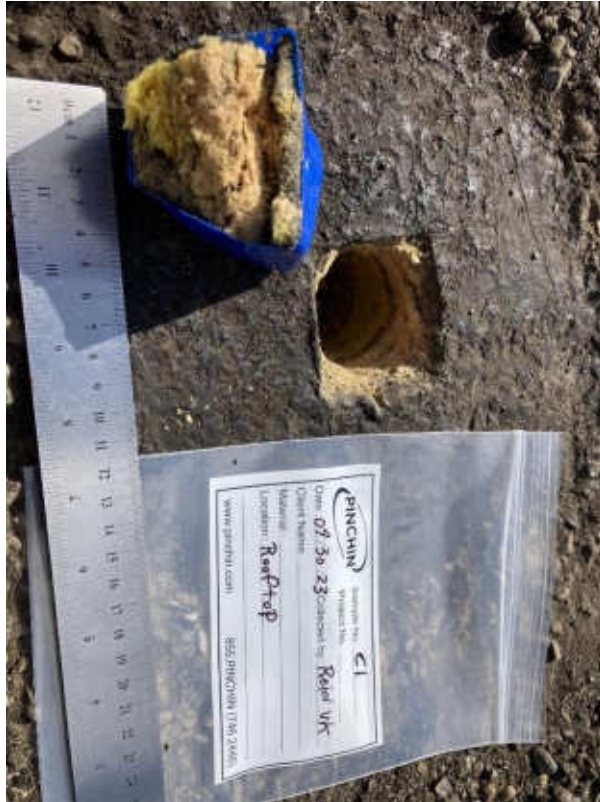
S1014C (Confirmed Asbestos), Roof materials, Roof C (Location #: 211)

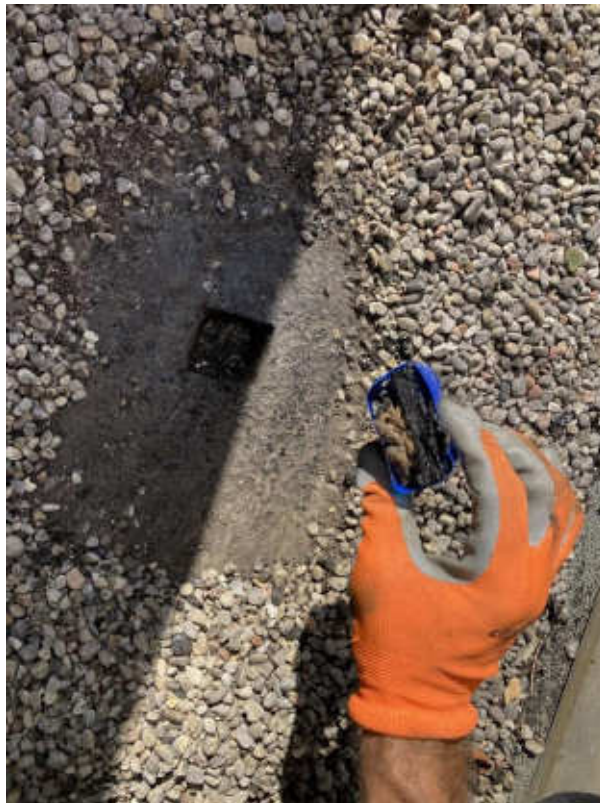
S1015A (Non-asbestos), Roof materials, Roof A (Location #: 209)

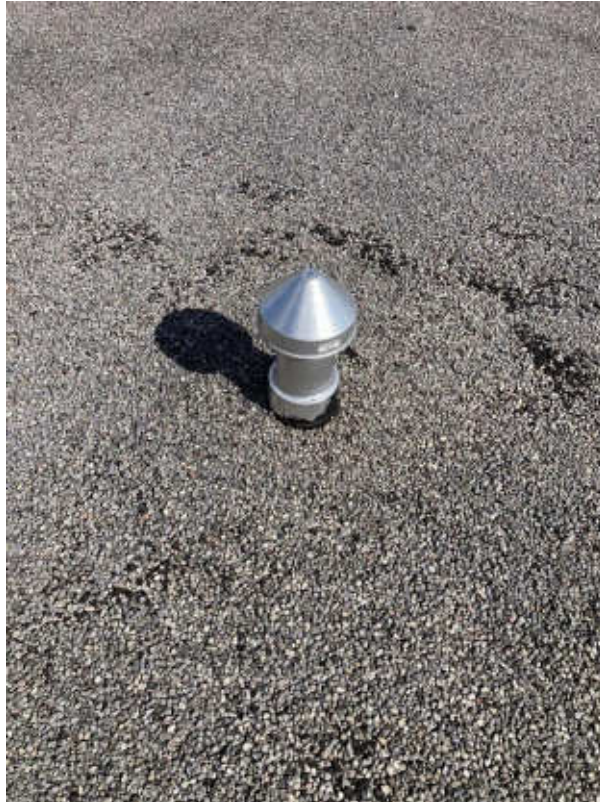
S1016A (Non-asbestos), Black tar on vent, Roof B (Location #: 210)

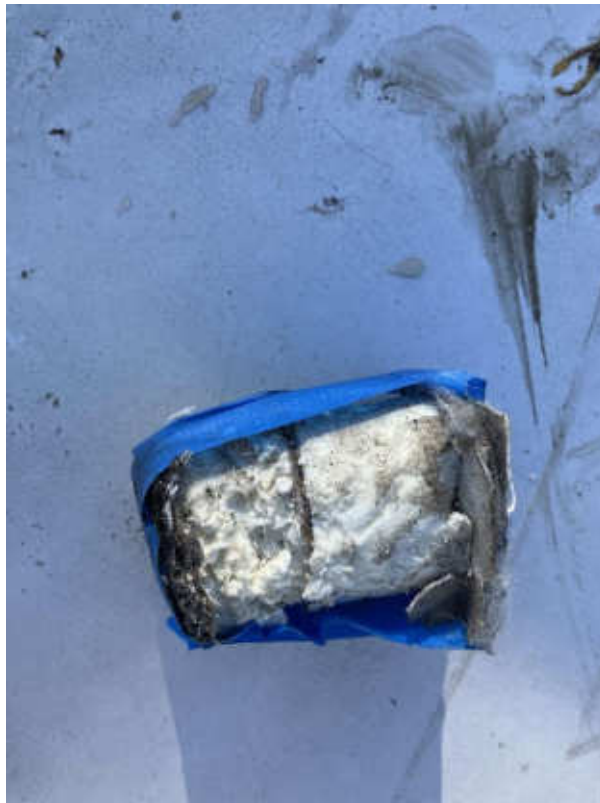
S1018A (Non-asbestos), Roofing materials, Roof D (Location #: 213)

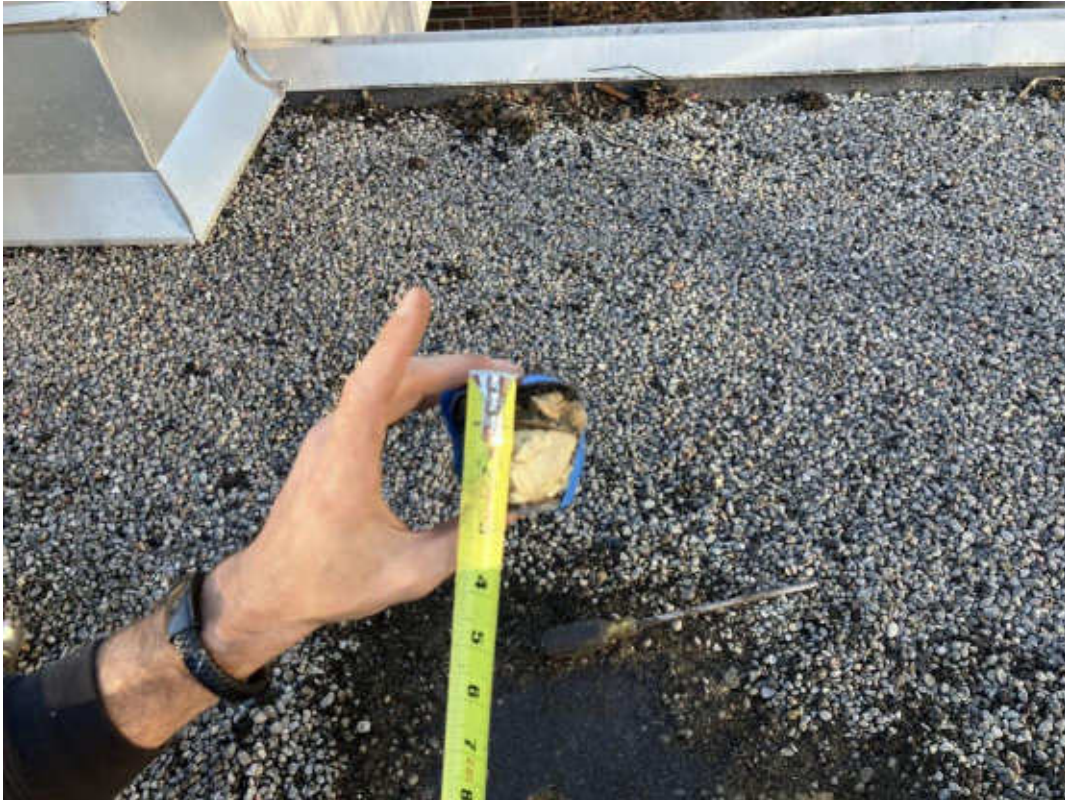
S1019A (Non-asbestos), Roofing materials, Roof E (Location #: 214)

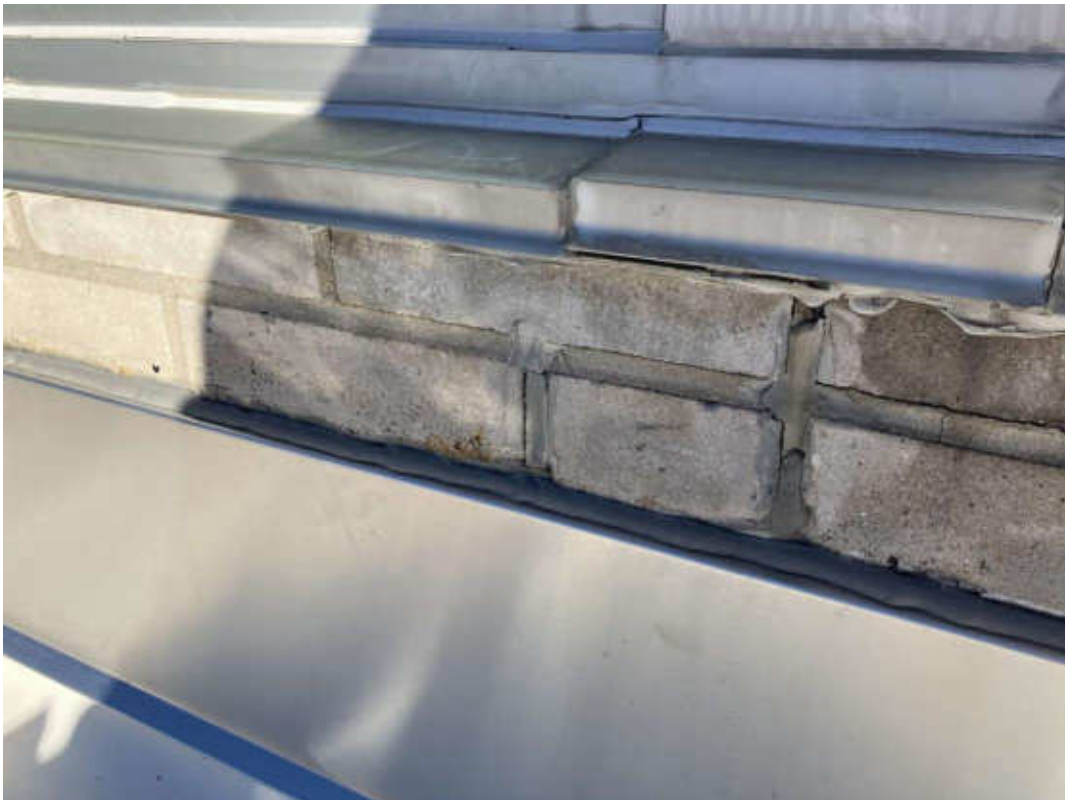
S1020A (Non-asbestos), Grey caulking on flashing, Roof D (Location #: 213)

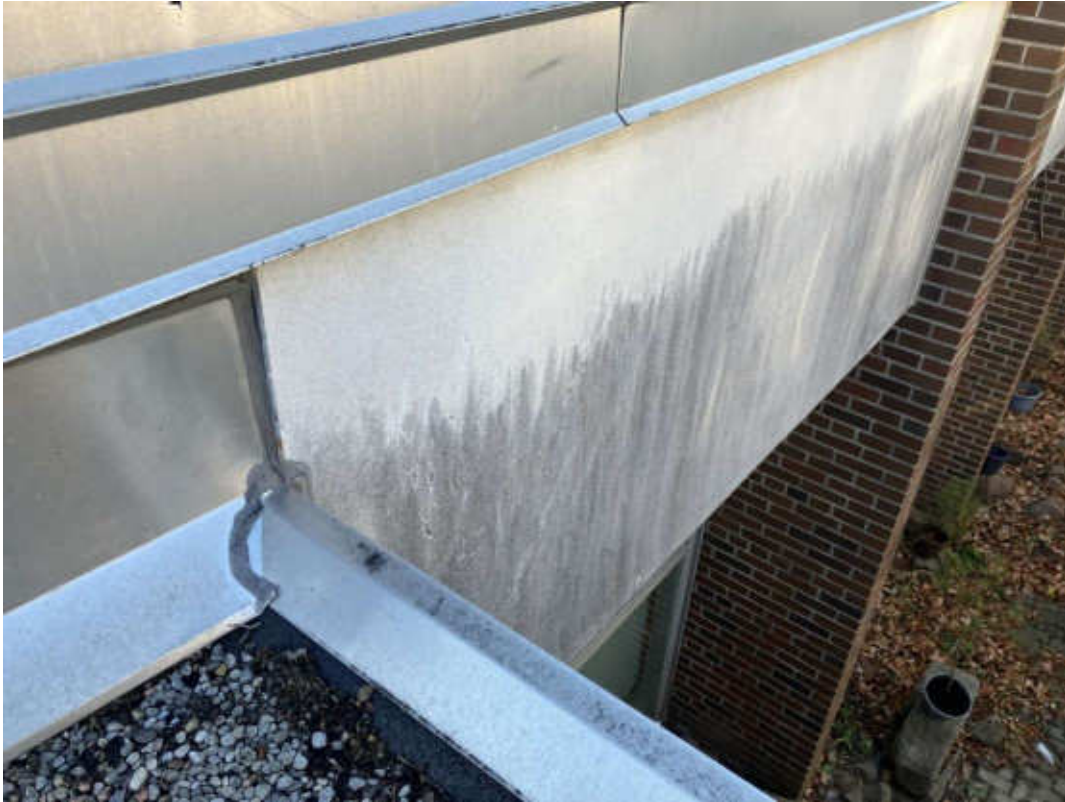
S1021A (Non-asbestos), Grey caulking on flashing, Roof E (Location #: 214)  
Note: adjacent to asbestos-containing cement board

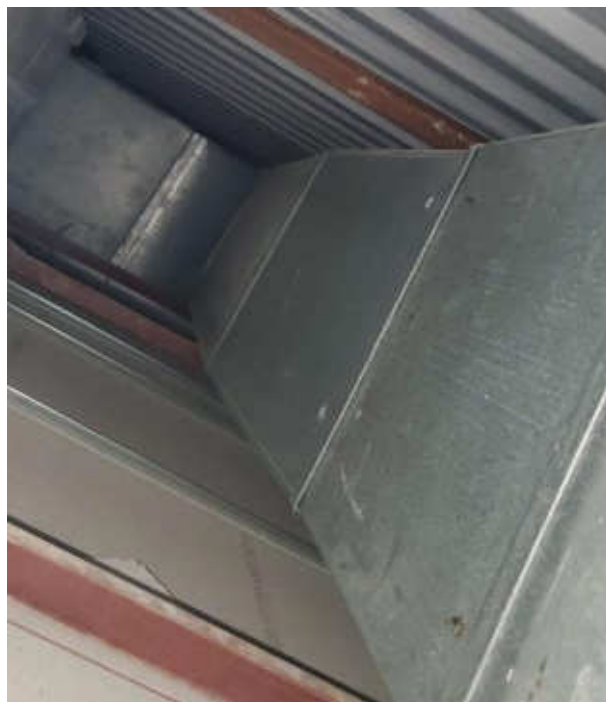
Duct, All, Not Insulated, Cafeteria (Location #: 103)

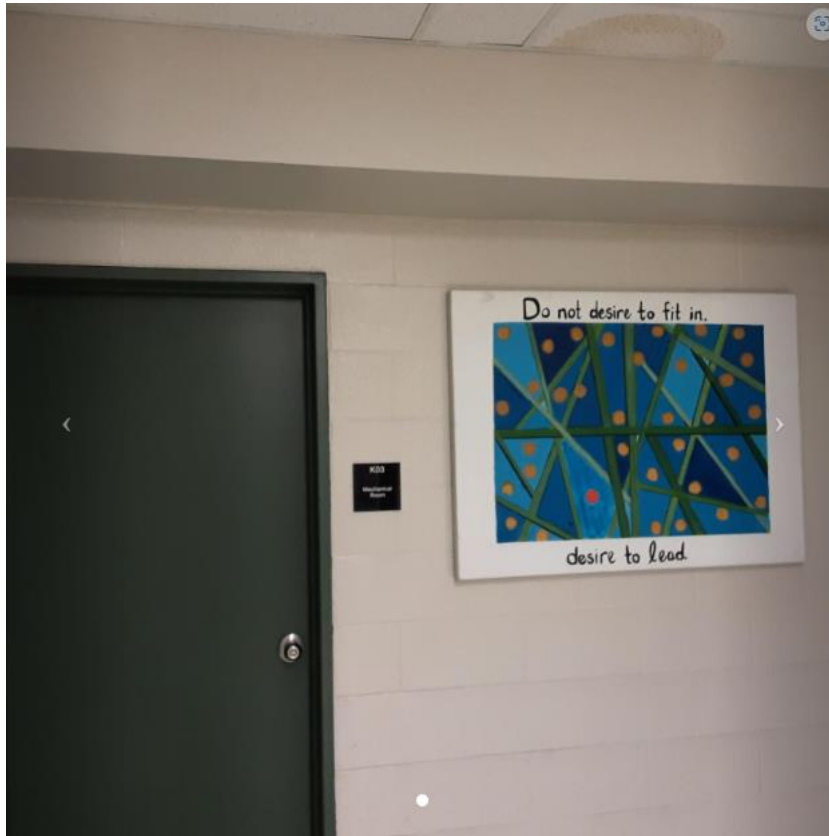
V0011 (Confirmed Asbestos) Drywall and Joint Compound on Bulkhead in Loc. 100

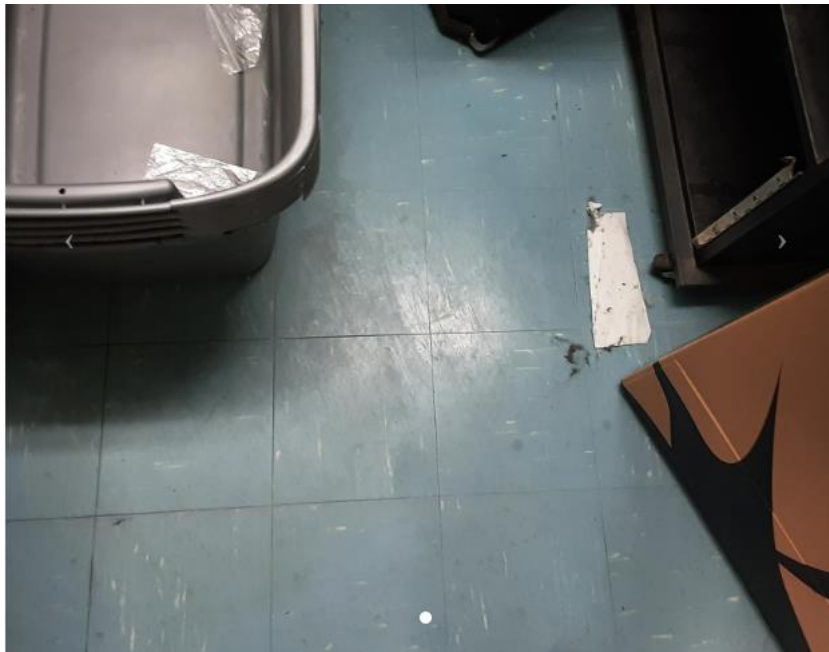
S0025 (Confirmed Asbestos) 9"x9" Blue with White Streak Vinyl Floor Tile and Mastic in Loc. 104

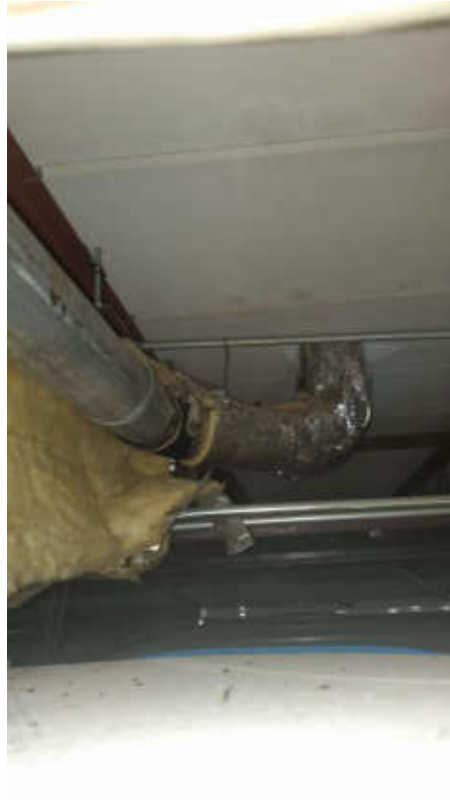
Piping, (non-asbestos) Fibreglass insulation on Rainwater Leader, Staff Room (Location #: 190)

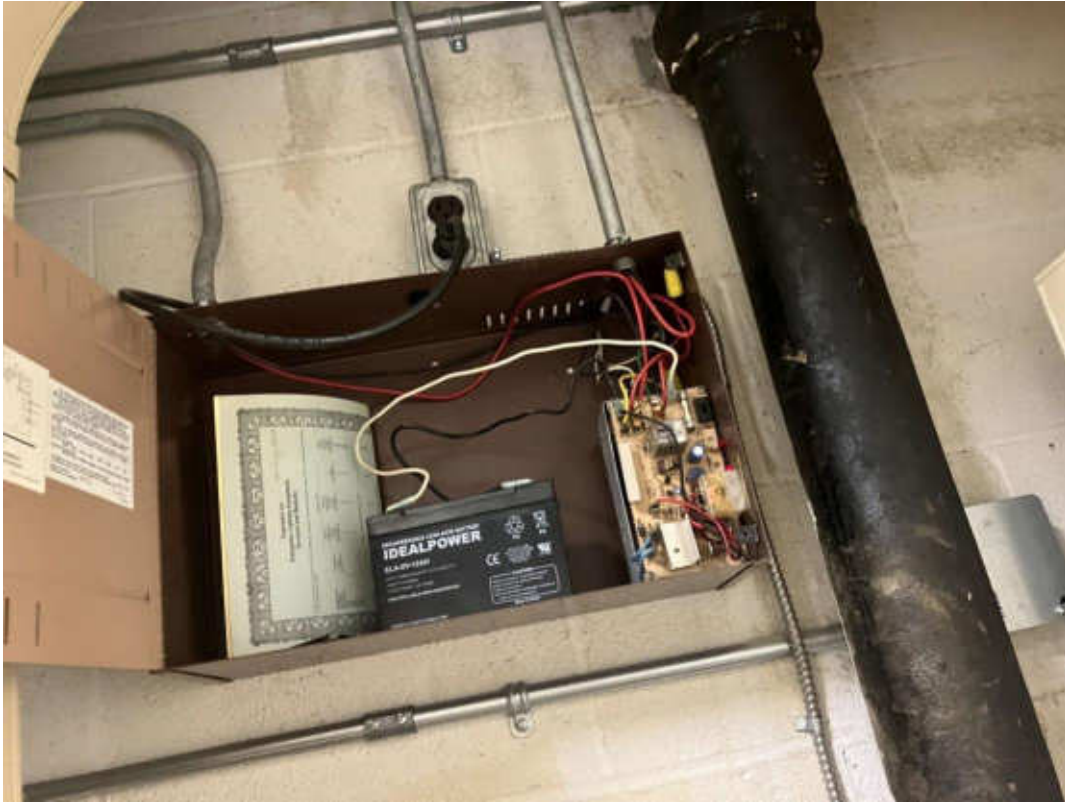
Items identified as Sample Number V9000 were observed to be present and were determined to contain lead based on visual observation.

Pb (Lead) Products, V9000(Yes), Lead containing Batteries in Emer. Lights, Mechanical Room (Location #: 186)
