**HPEDSB Addendum #1
RFQ 2425-003 Fire Alarm Renewal at
Centennial Secondary School**

Re: Hazardous Building Materials Assessment (Preconstruction)
Centennial Secondary School Fire Alarm Upgrade Project
Centennial Secondary School, 160 Palmer Road, Belleville, ON
Pinchin File: 200584.095

Hastings And Prince Edward District School Board (Client) retained Pinchin Ltd. (Pinchin) to conduct a hazardous building materials assessment of Centennial Secondary School located at 160 Palmer Road, Belleville, ON.

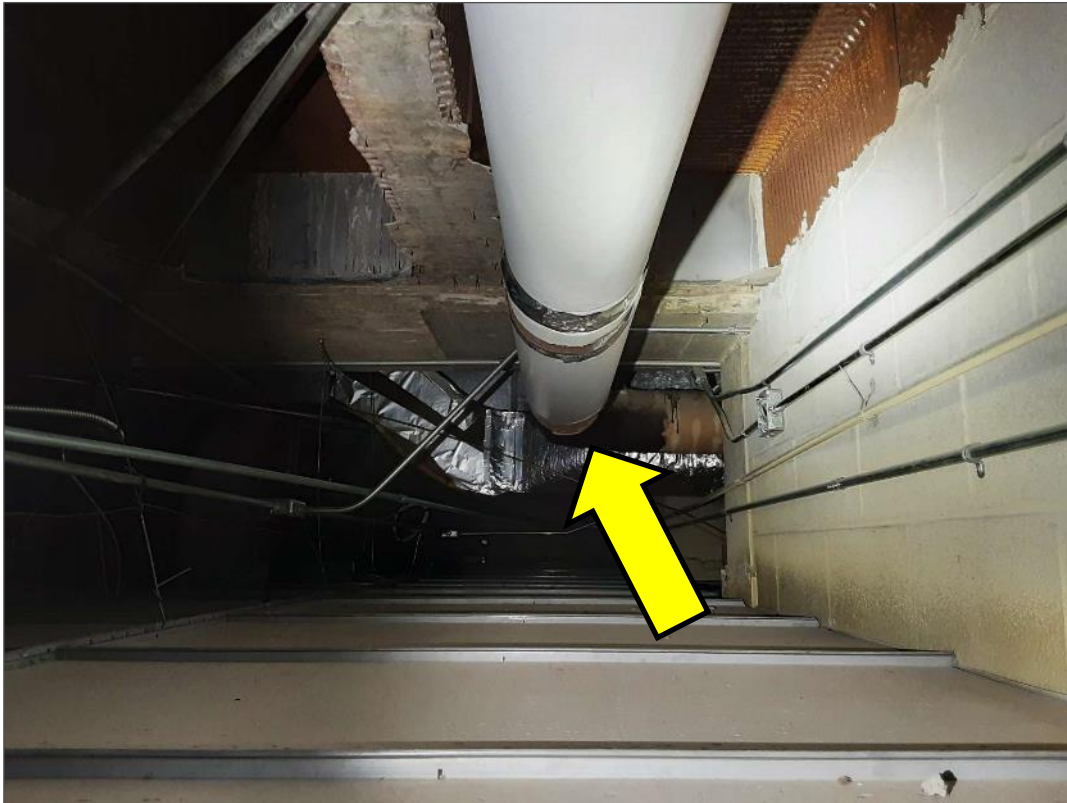
V0001 - (Confirmed Asbestos) Piping, Mastic, Over Parging Cement, 293 (Location #: 2920)

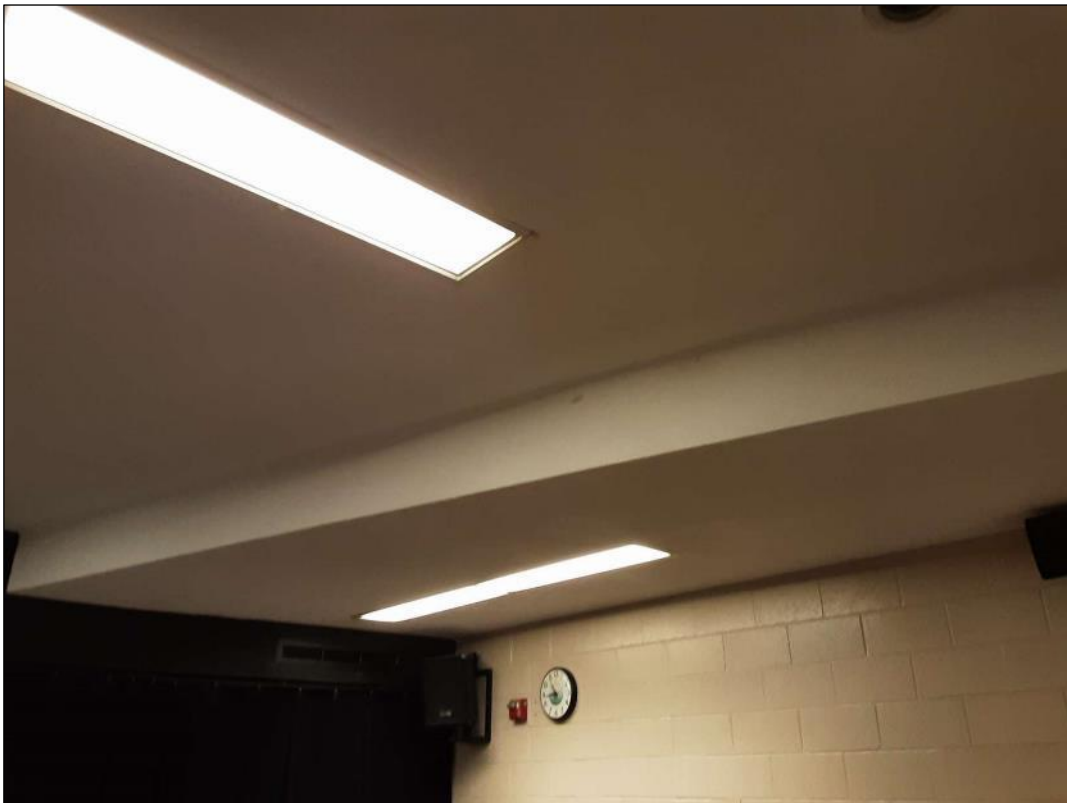
S0004A - (Confirmed Asbestos) Ceiling, Texture Coat, 102 (Location #: 1000)

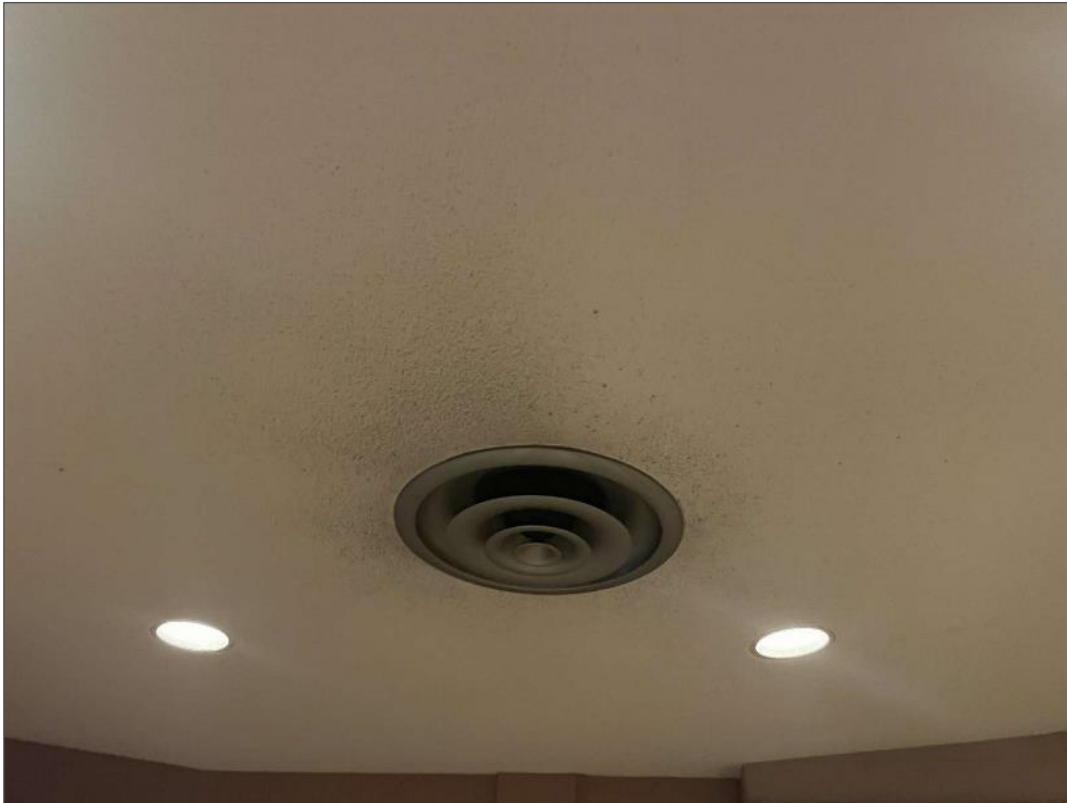
S0005A (Confirmed Asbestos), Ceiling, Texture Coat, 101 (Location #: 1610)

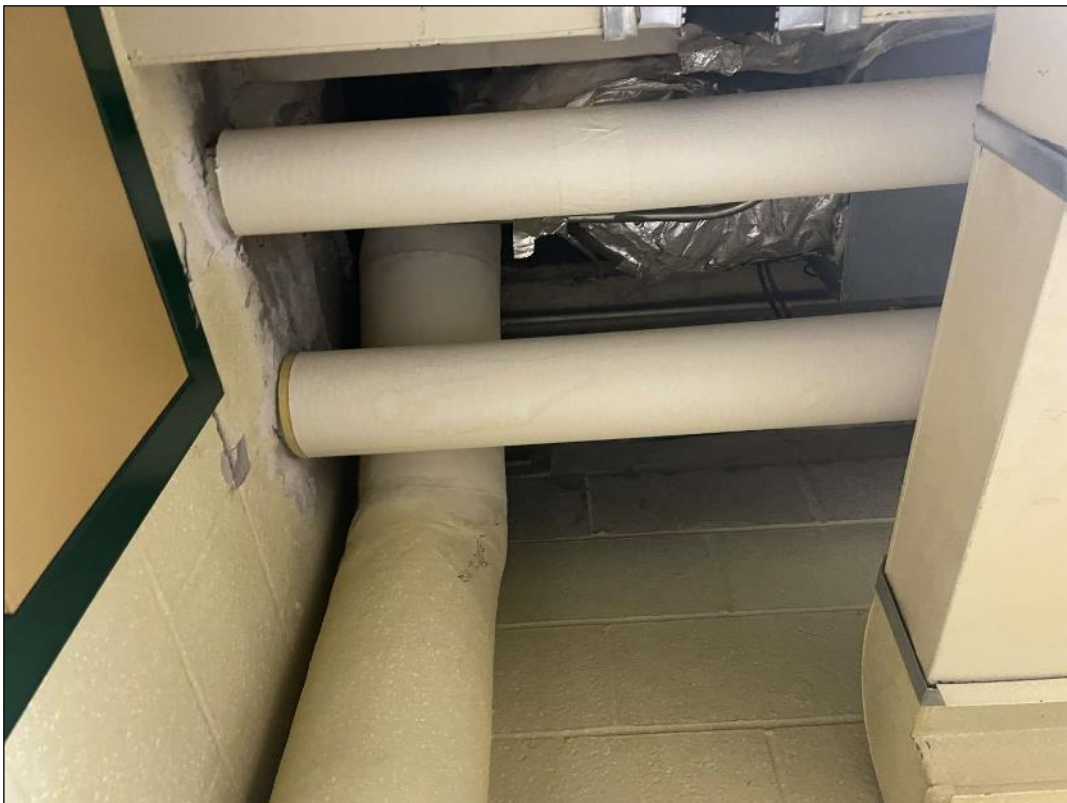
V0006 (Confirmed Asbestos), Piping, Parging Cement, 111 (Location #: 1361)

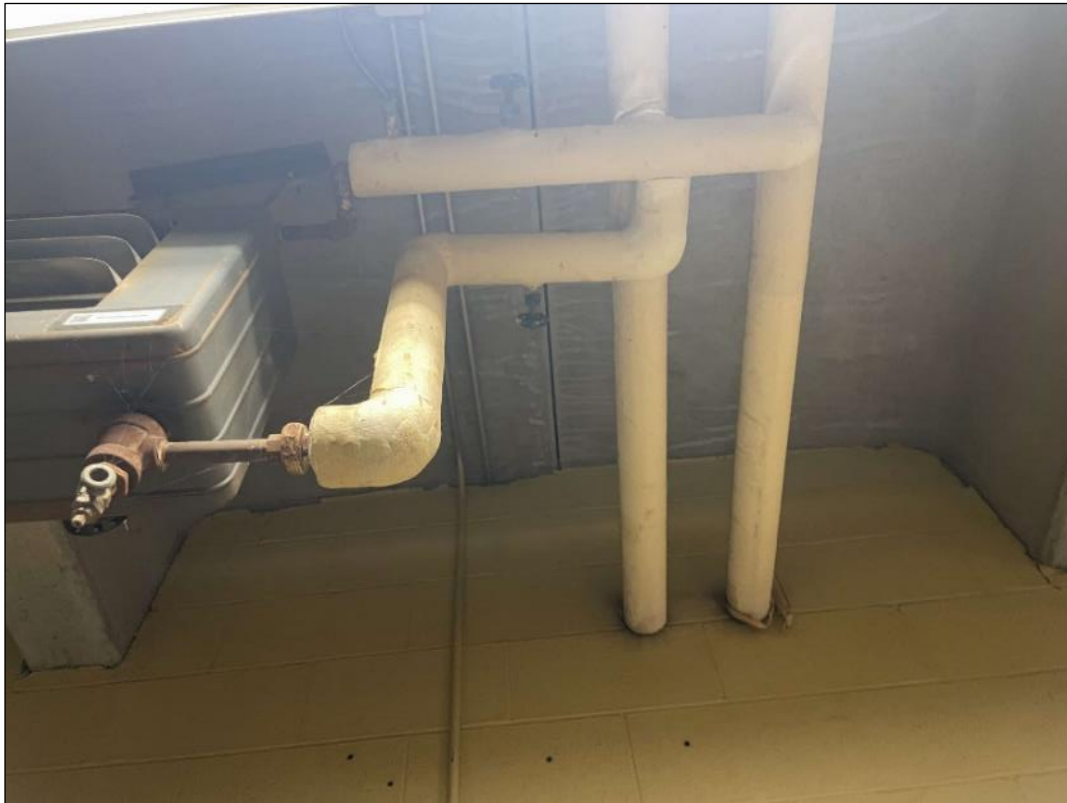
V0006 (Confirmed Asbestos), Piping, Parging Cement, 155 (Location #: 1710)

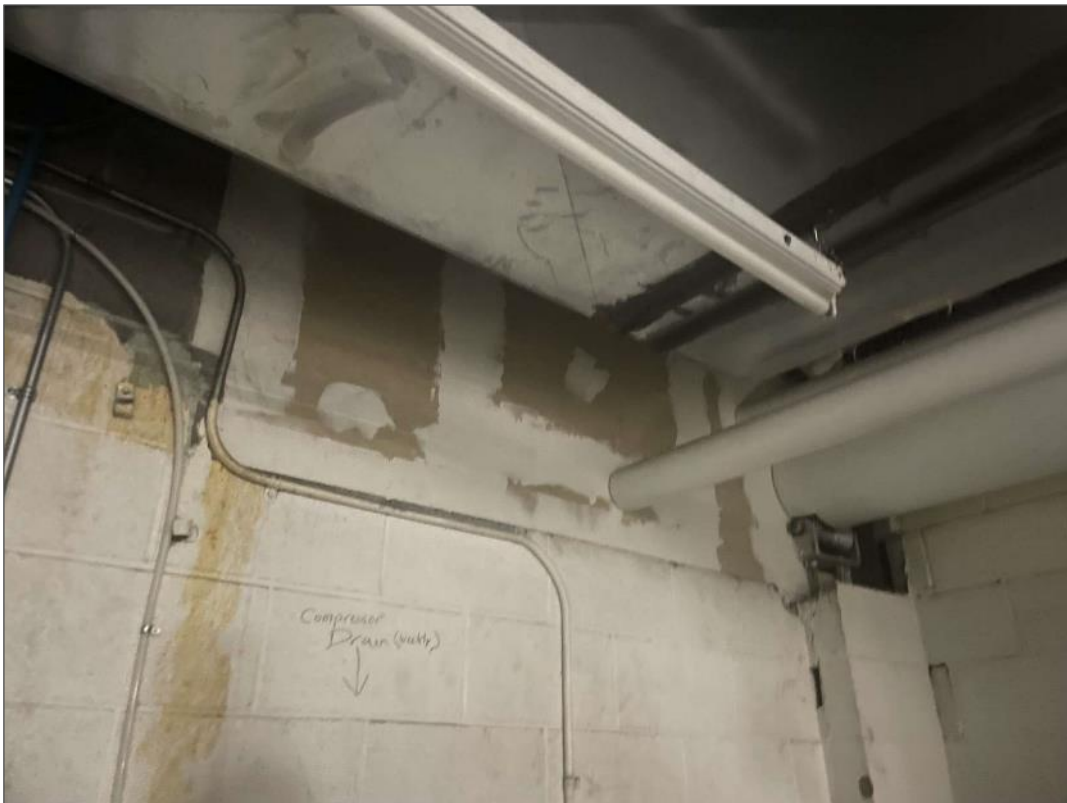
S0015A (None), Wall, Paint, 300 (Location #: 301)

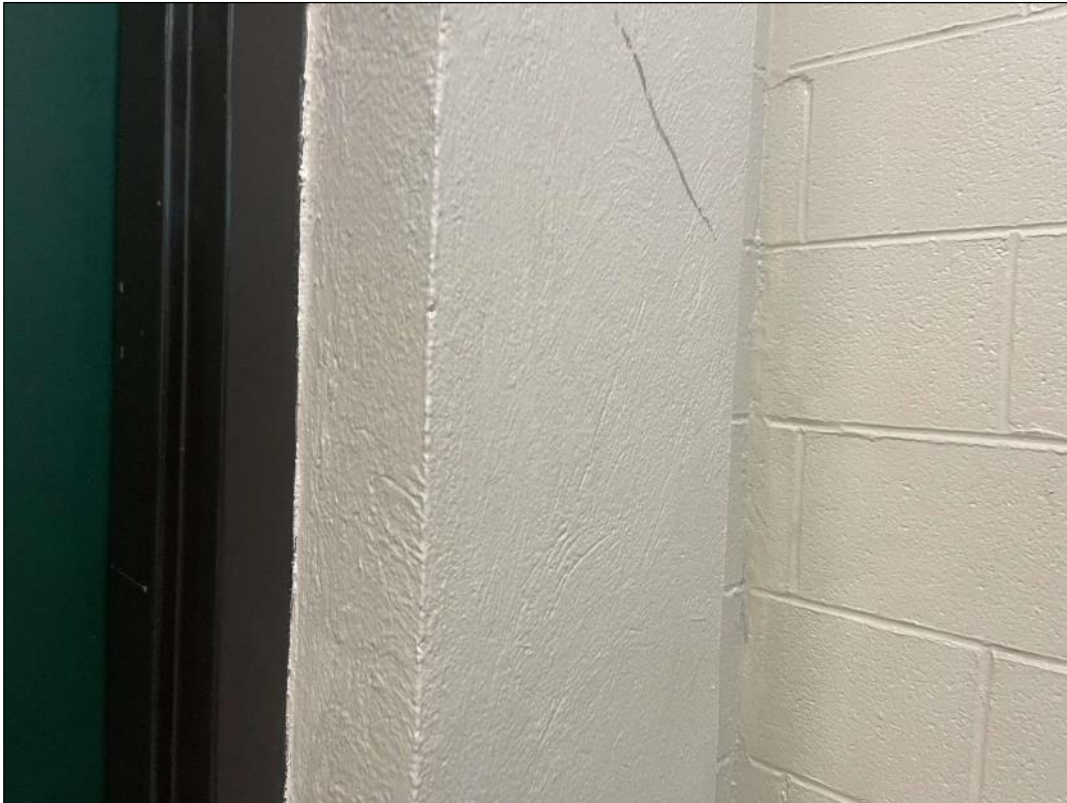
S0016A (None), Structure, Column, Paint, 233 (Location #: 2310)

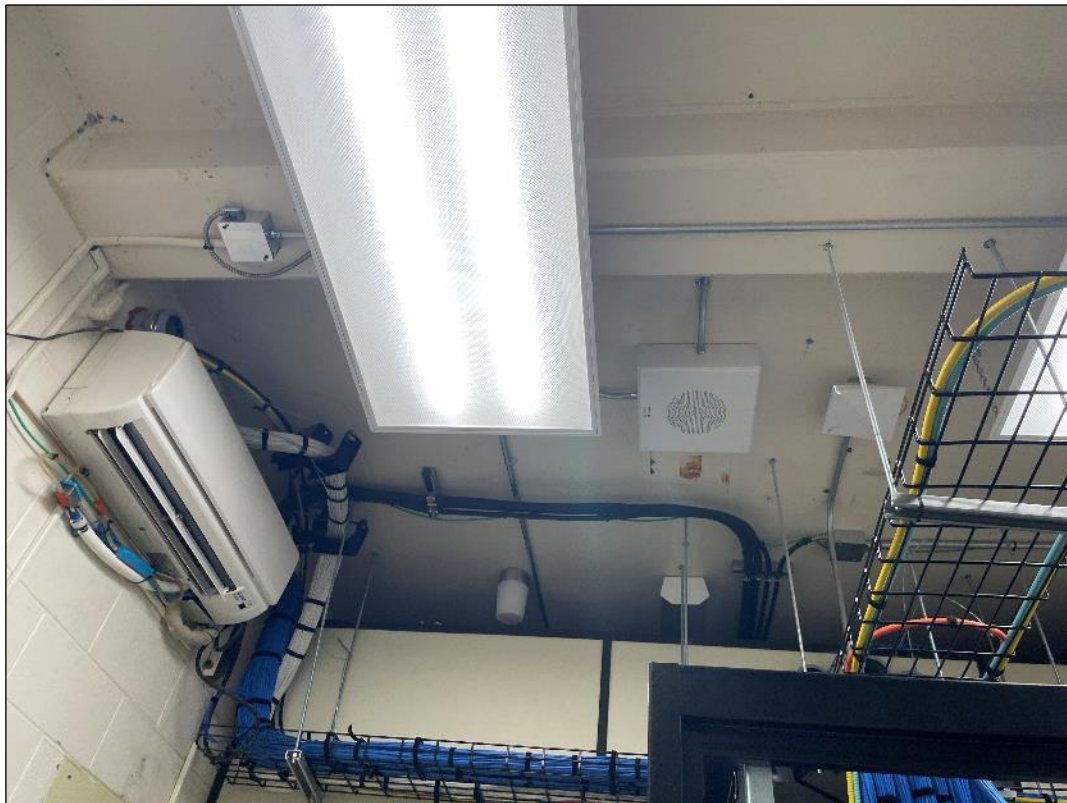
3. Asbestos-containing paint on the poured concrete roof deck, and asbestos-containing caulking between deck joints, were observed in several locations. These ACMs may be present within inaccessible areas throughout the building, such as above solid ceilings.

V0018 (Confirmed Asbestos), Structure, Deck, Paint, 233 (Location #: 1640)

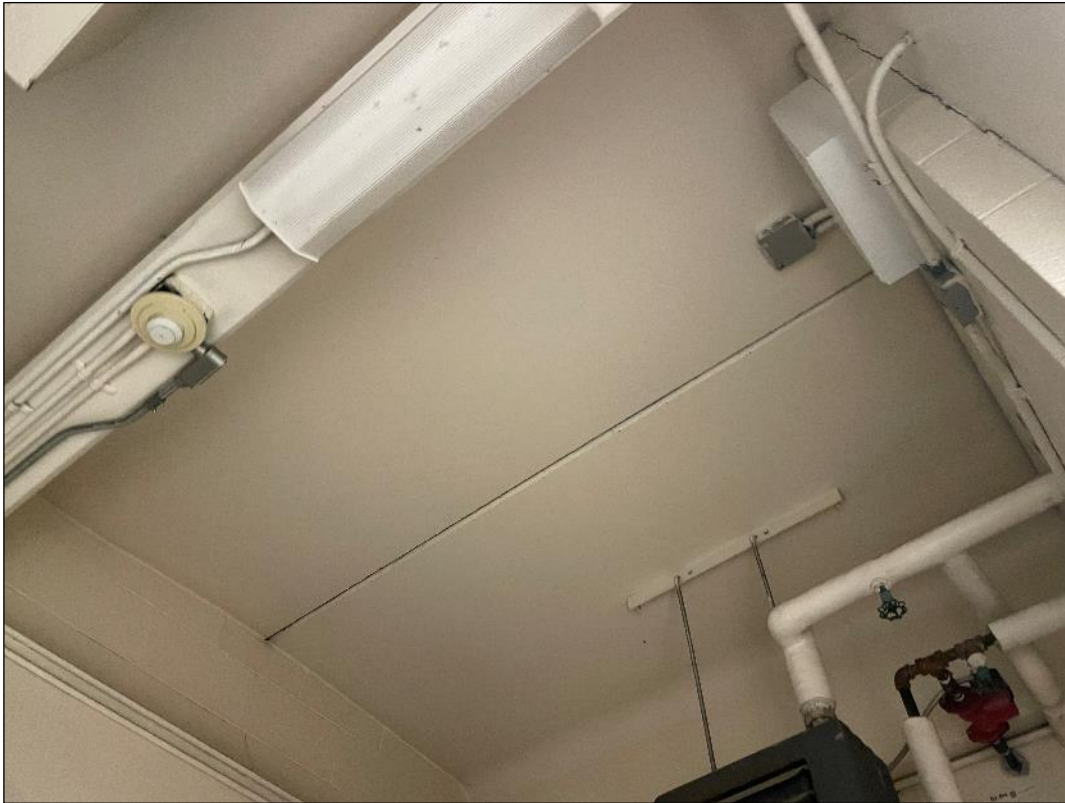
V0019 (Confirmed Asbestos), Structure, Deck, Caulking, 233 (Location #: 1772)

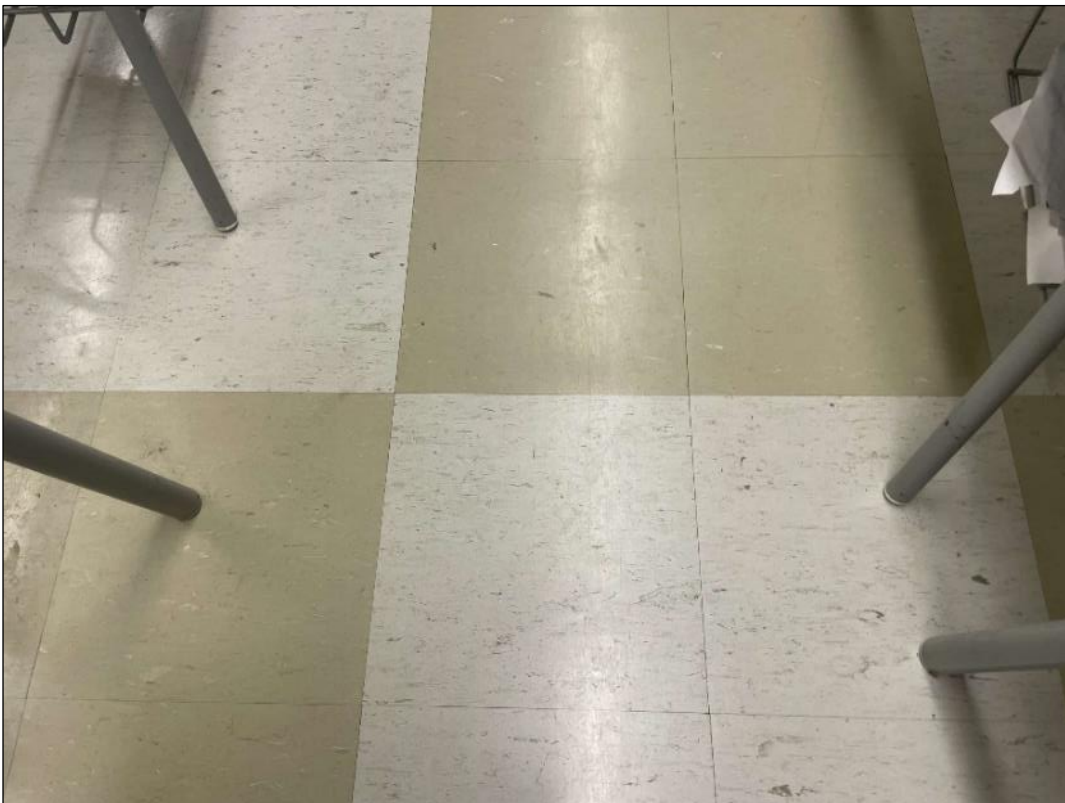
V9000 (Confirmed Asbestos), VT-5, 12x12 pale green, Floor, Vinyl Floor Tile, 205 (Location #: 2050)
Previous samples ASB-125.1-3

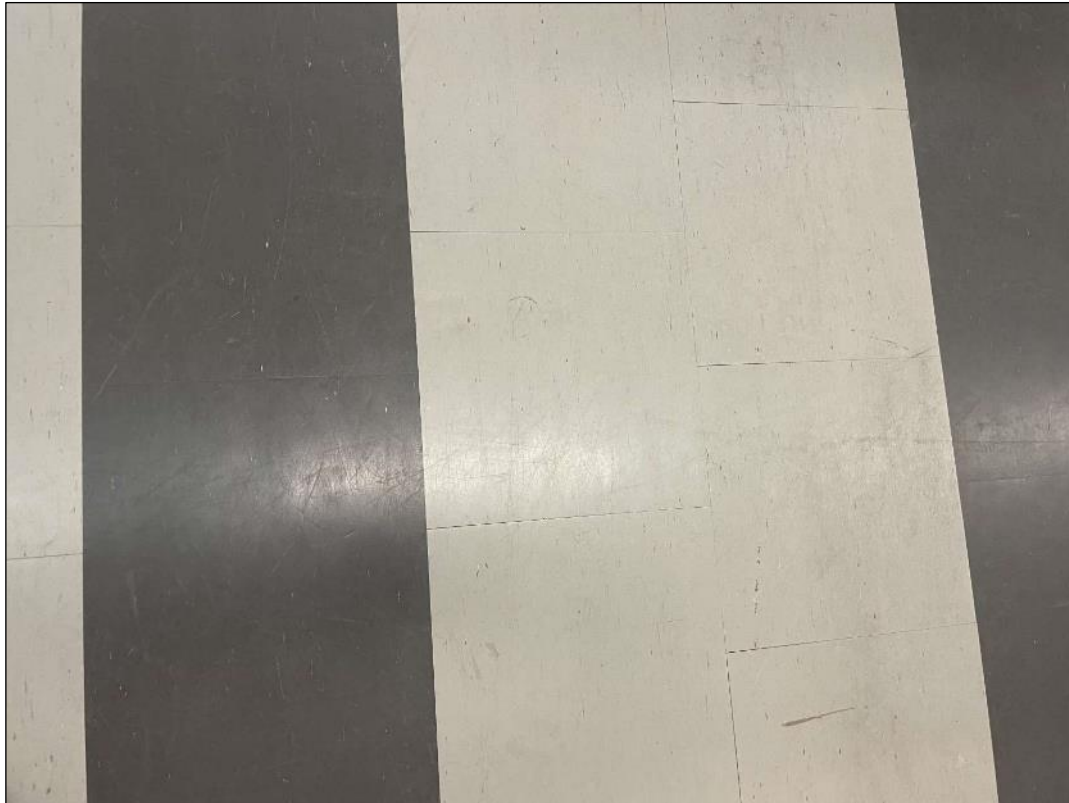
V9000 (Confirmed Asbestos), VT-9, 12x12, off-white, Floor, Vinyl Floor Tile, 233 (Location #: 2310)
Historic data

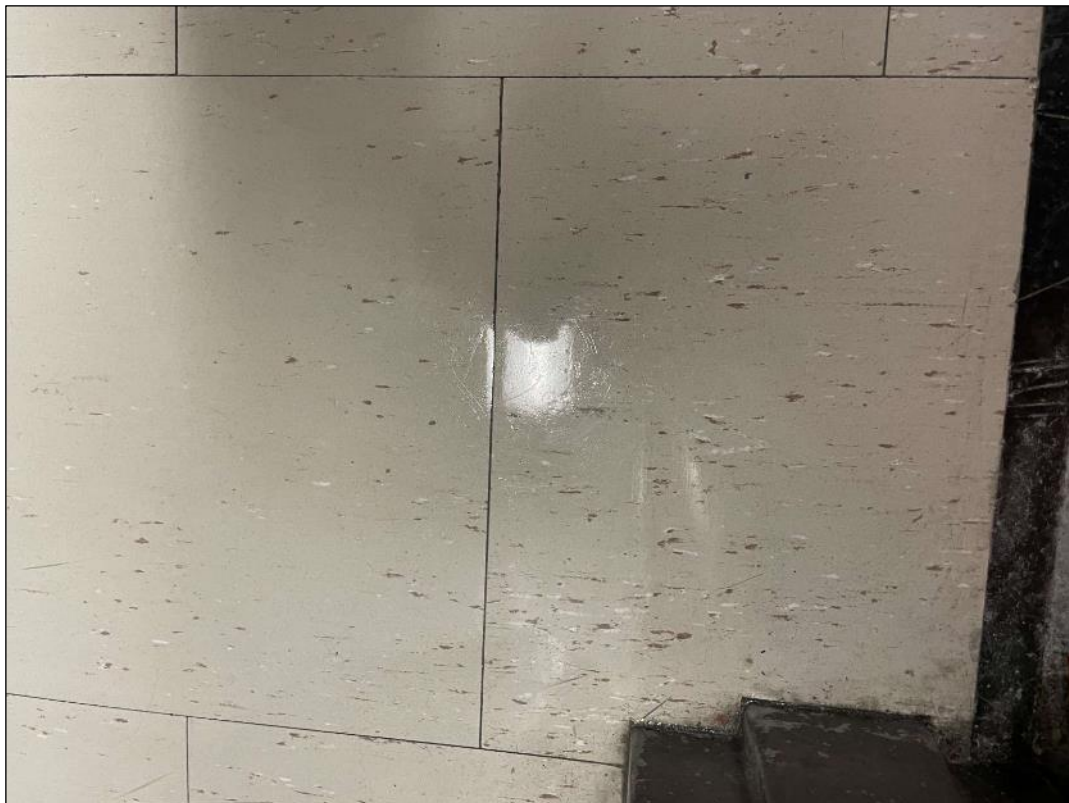
V9000 (Confirmed Asbestos), VT-9, 12x12 off-white, Floor, Vinyl Floor Tile, 223 (Location #: 2900)
Historic data

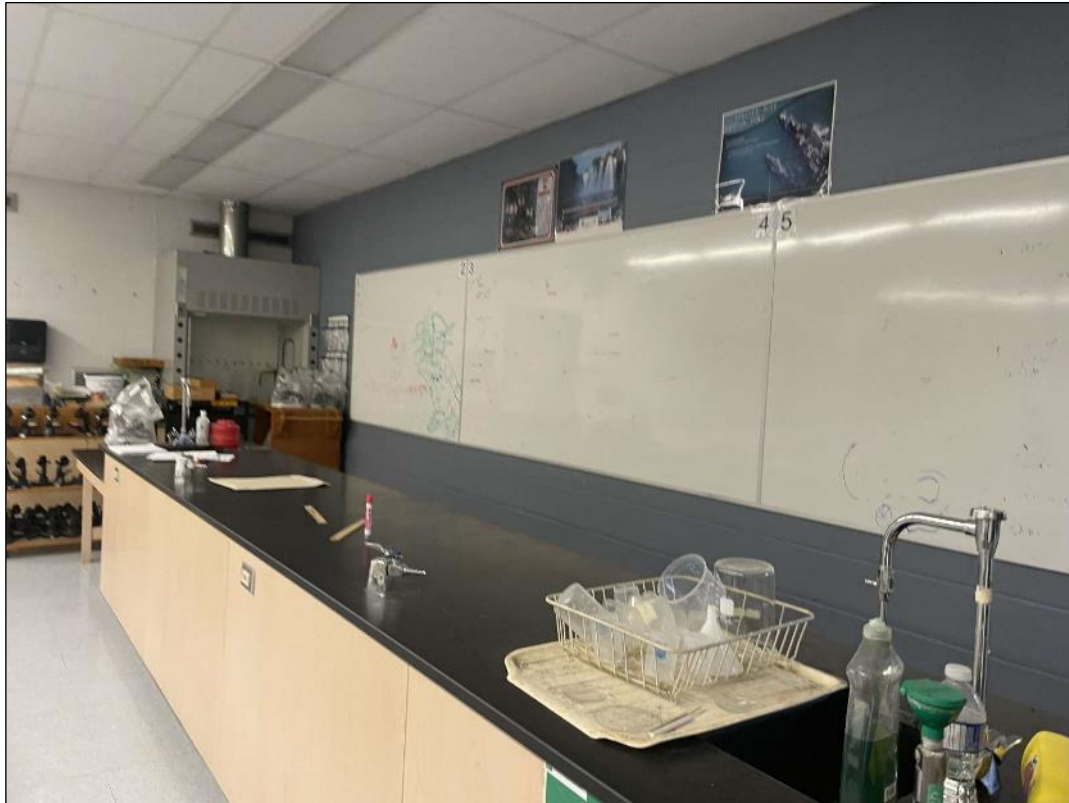
V9500 (Presumed Asbestos), Other, Countertop, Cement Product, 238 (Location #: 2820)

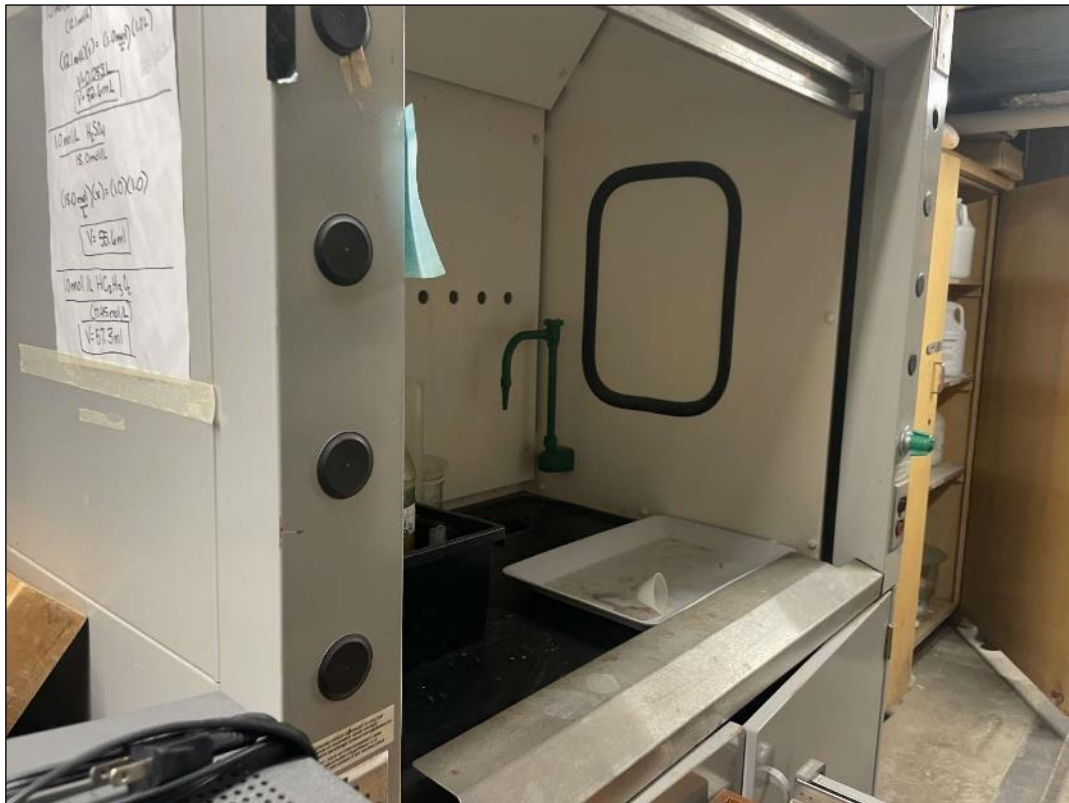
V9500 (Presumed Asbestos), Other, Fumehood, Cement Product, 238 (Location #: 2820)

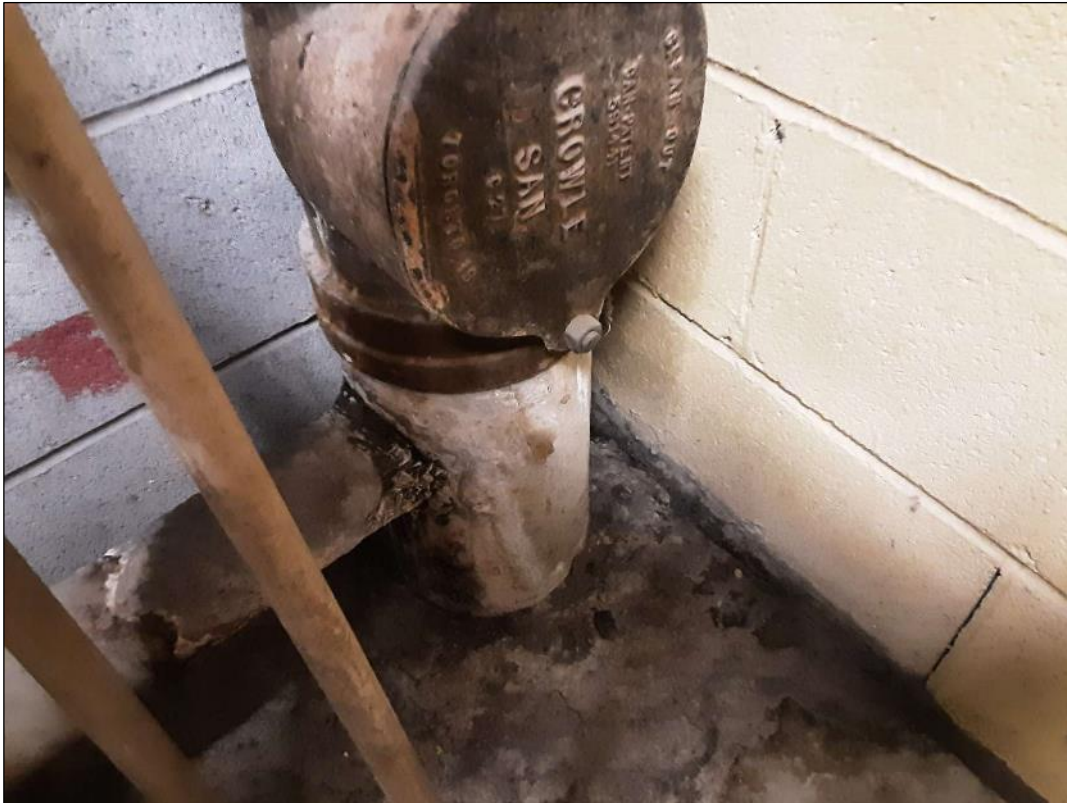
V9500 - (Presumed Asbestos), Piping, Rain Water Leader, Cement Product (Transite), 154 (Location #: 1730)

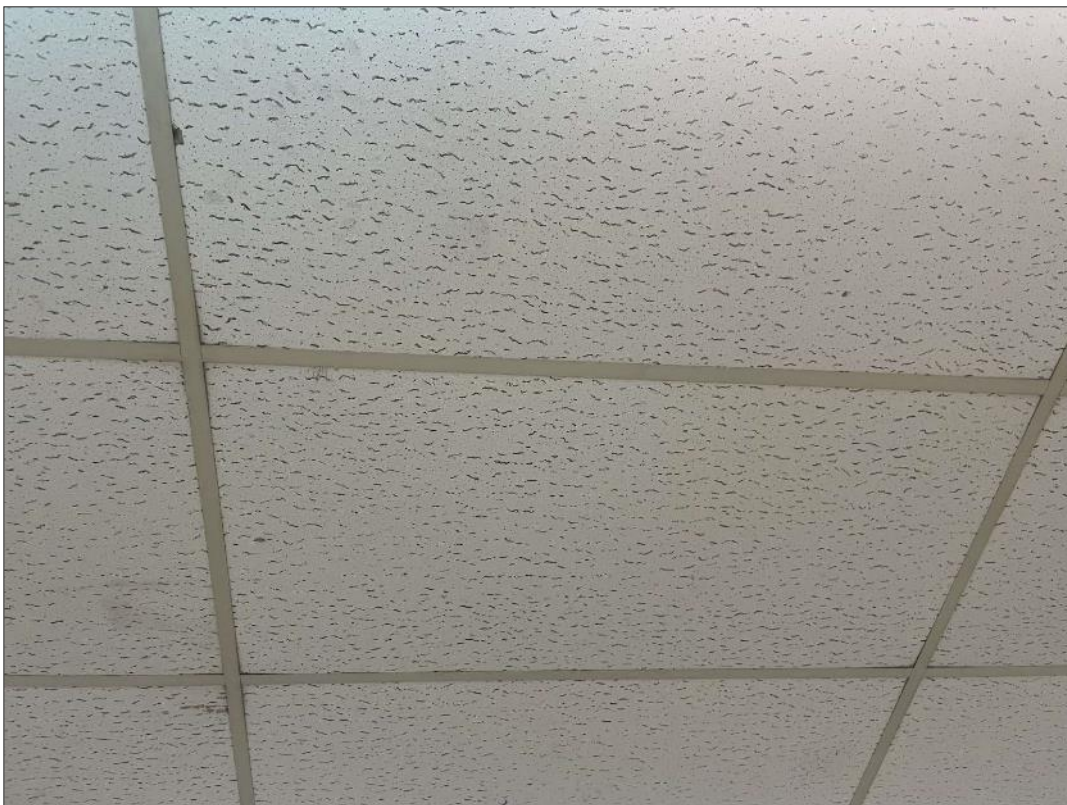
V0000 (None), 24x48 lay-in, fissures across length, Ceiling, Ceiling Tiles (lay-in), 233 (Location #: 2310)
Previous samples ASB-103.1-3

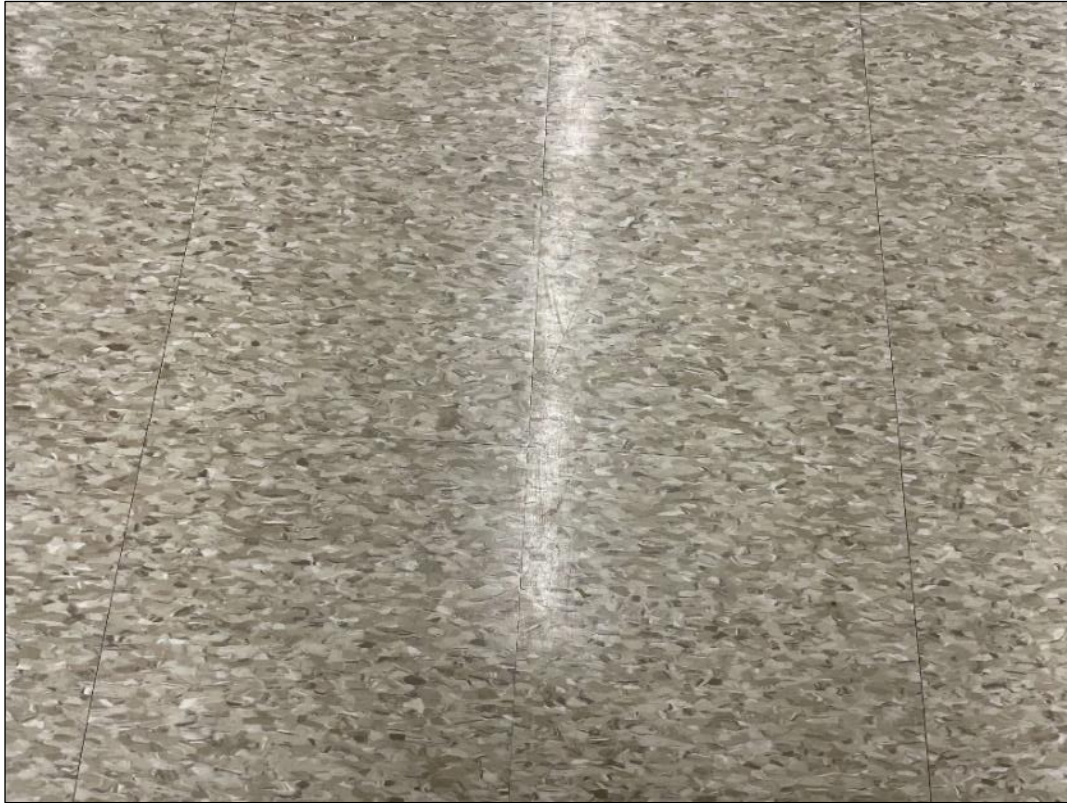
V0000 (None), 12x12 light brown with dark brown and white smears, installed post-2017, Floor, Vinyl Floor Tile and Mastic, 227 (Location #: 2360)

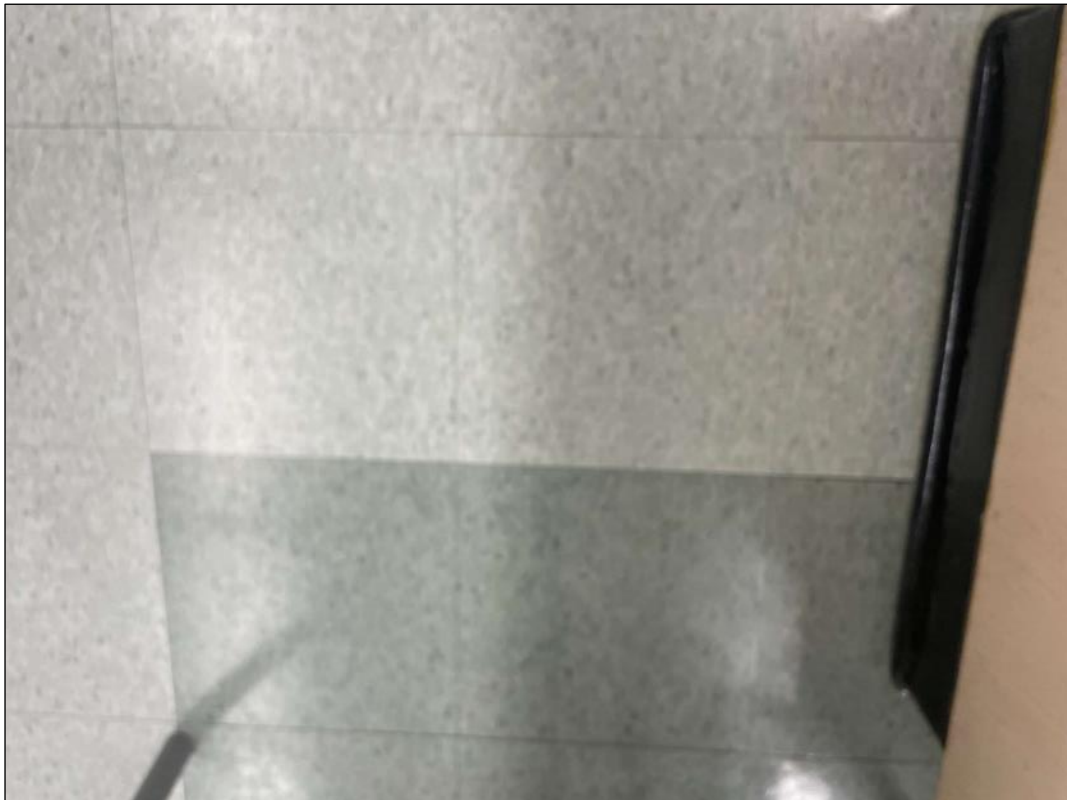
V0000 (None), 12x12 mottled light blue, Floor, All, Vinyl Floor Tile and Mastic, 238 (Location #: 2820)
Previous samples ASB-111.1-3

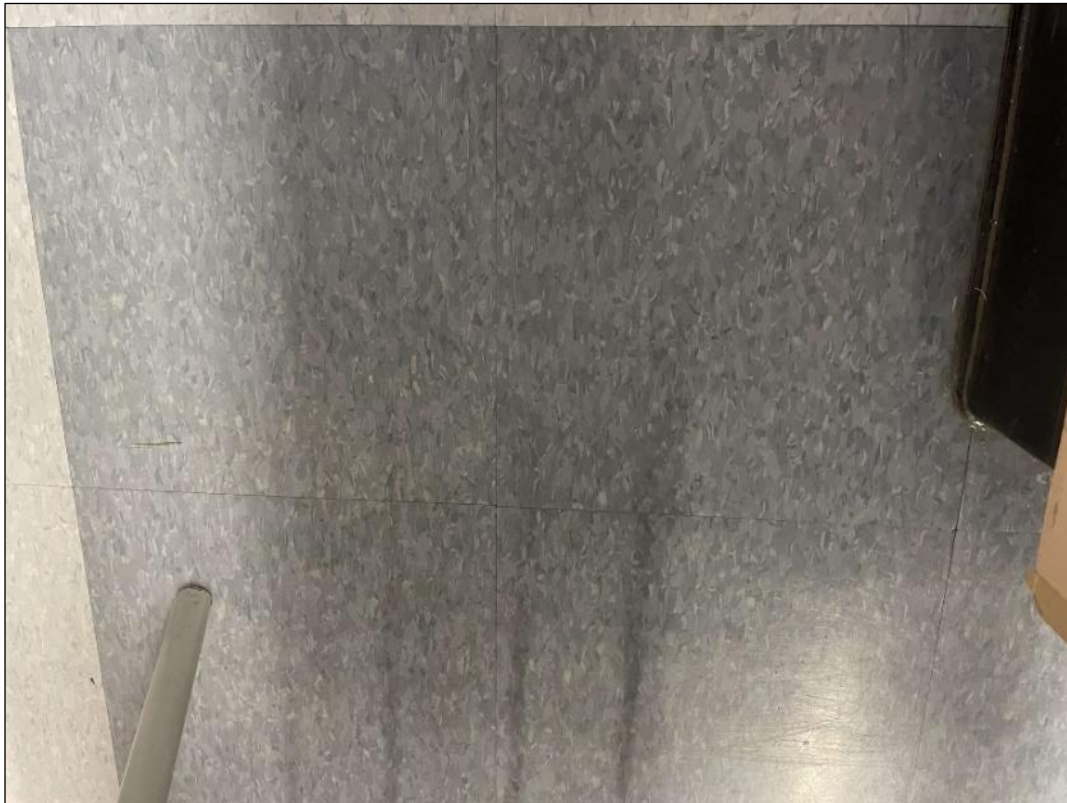
V0000 (None), 12x12 mottled dark blue, Floor, All, Vinyl Floor Tile and Mastic, 238 (Location #: 2820)
Previous samples ASB-112.1-3

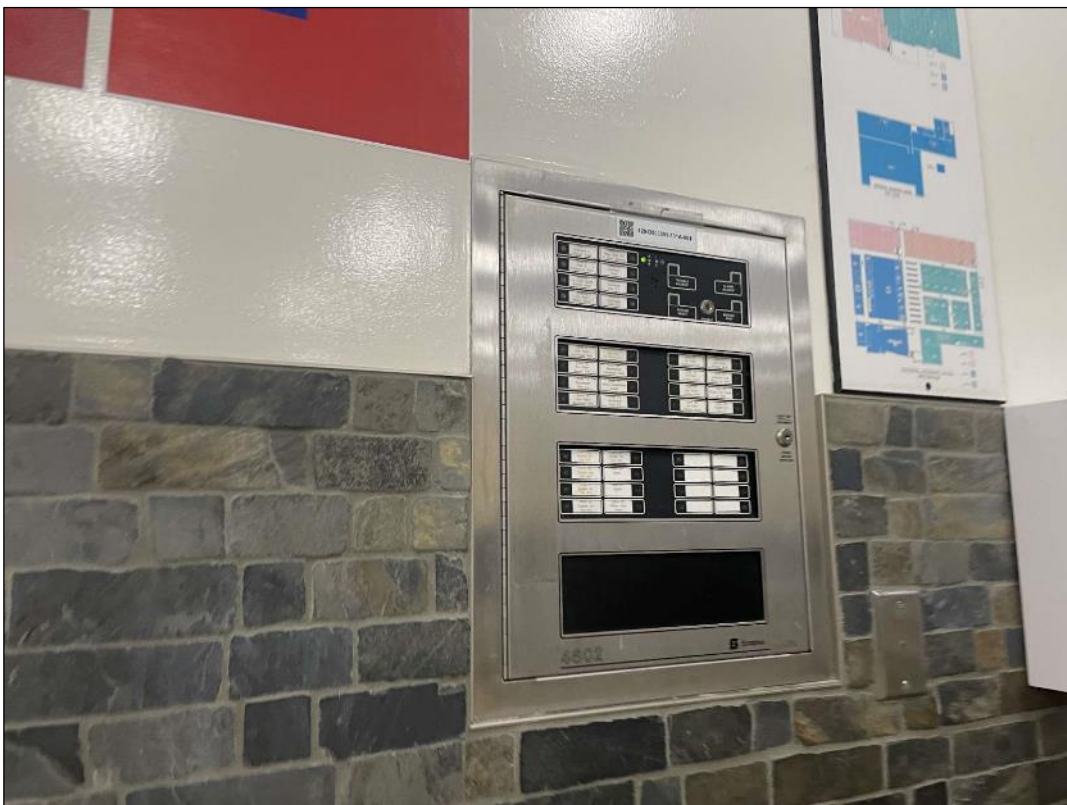
Pb Products, V9500(Presumed), BATTERIES (OTHER), Fire alarm control panel, 190A (Location #: 1951)
