Hazardous Building Materials Assessment (Pre-construction)

Sutherland Campus, Main Building
599 Brealey Drive, Peterborough

October 18, 2024

Pinchin File: 347369

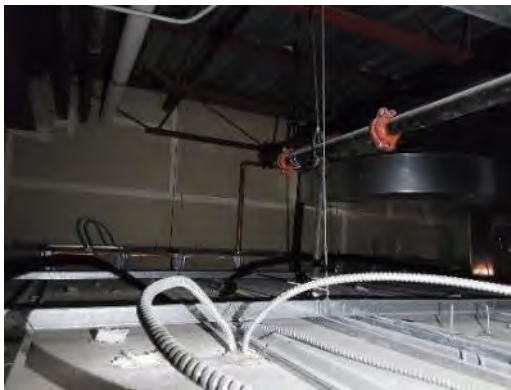
Uninsulated pipe in the Men's Washroom – B3174 (Loc. 191)

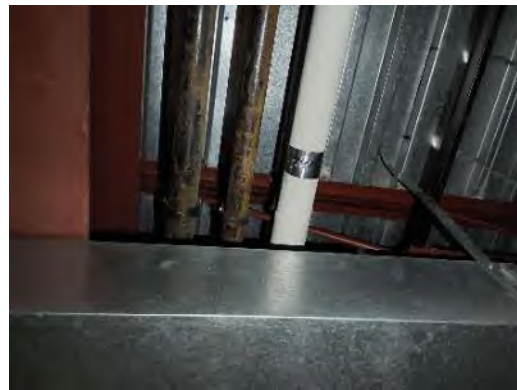
Pipe insulated with fibreglass in the Men's Washroom – B3174 (Loc. 191)

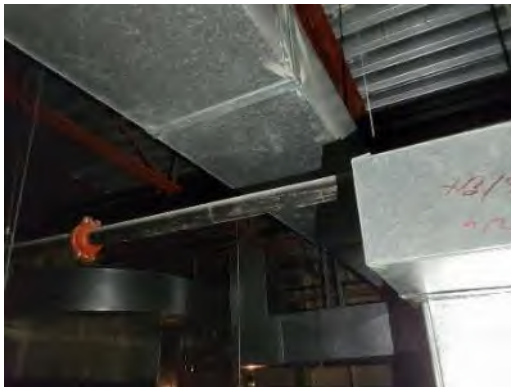
Uninsulated ducts in the Men's Washroom – B3174 (Loc. 191)

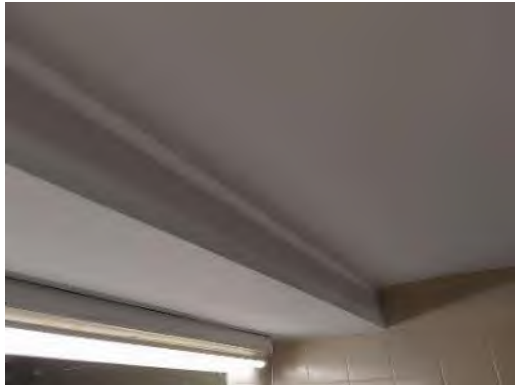
Drywall with non-asbestos joint compound on the ceiling in the Men's Washroom - C2126 (Loc. 403)

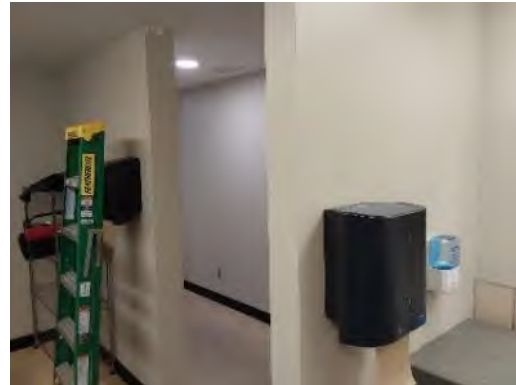
Drywall with non-asbestos joint compound on walls in the Women's Washroom – B3170 (Loc. 190)

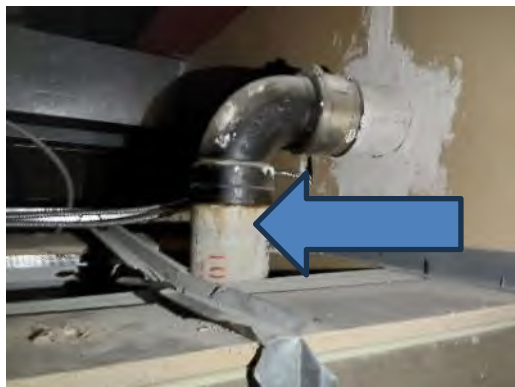
- Asbestos cement (Transite) pipe is present in the Men's Washroom – B3174 (Loc. 191).

Cement pipe (Transite), presumed to contain asbestos based on visual observation, is present as sanitary drains / rainwater leaders in the Men's Washroom – B3174 (Loc. 191).

Cement pipe (Transite) in the Men's Washroom – B3174 (Loc. 191)

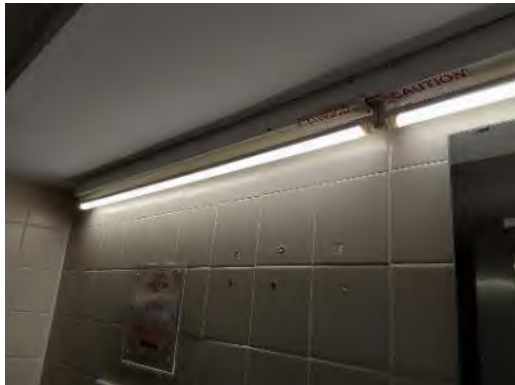
Light Emitting Diode (LED) T8 lamps in the Men's Washroom - C2126 (Loc. 403)

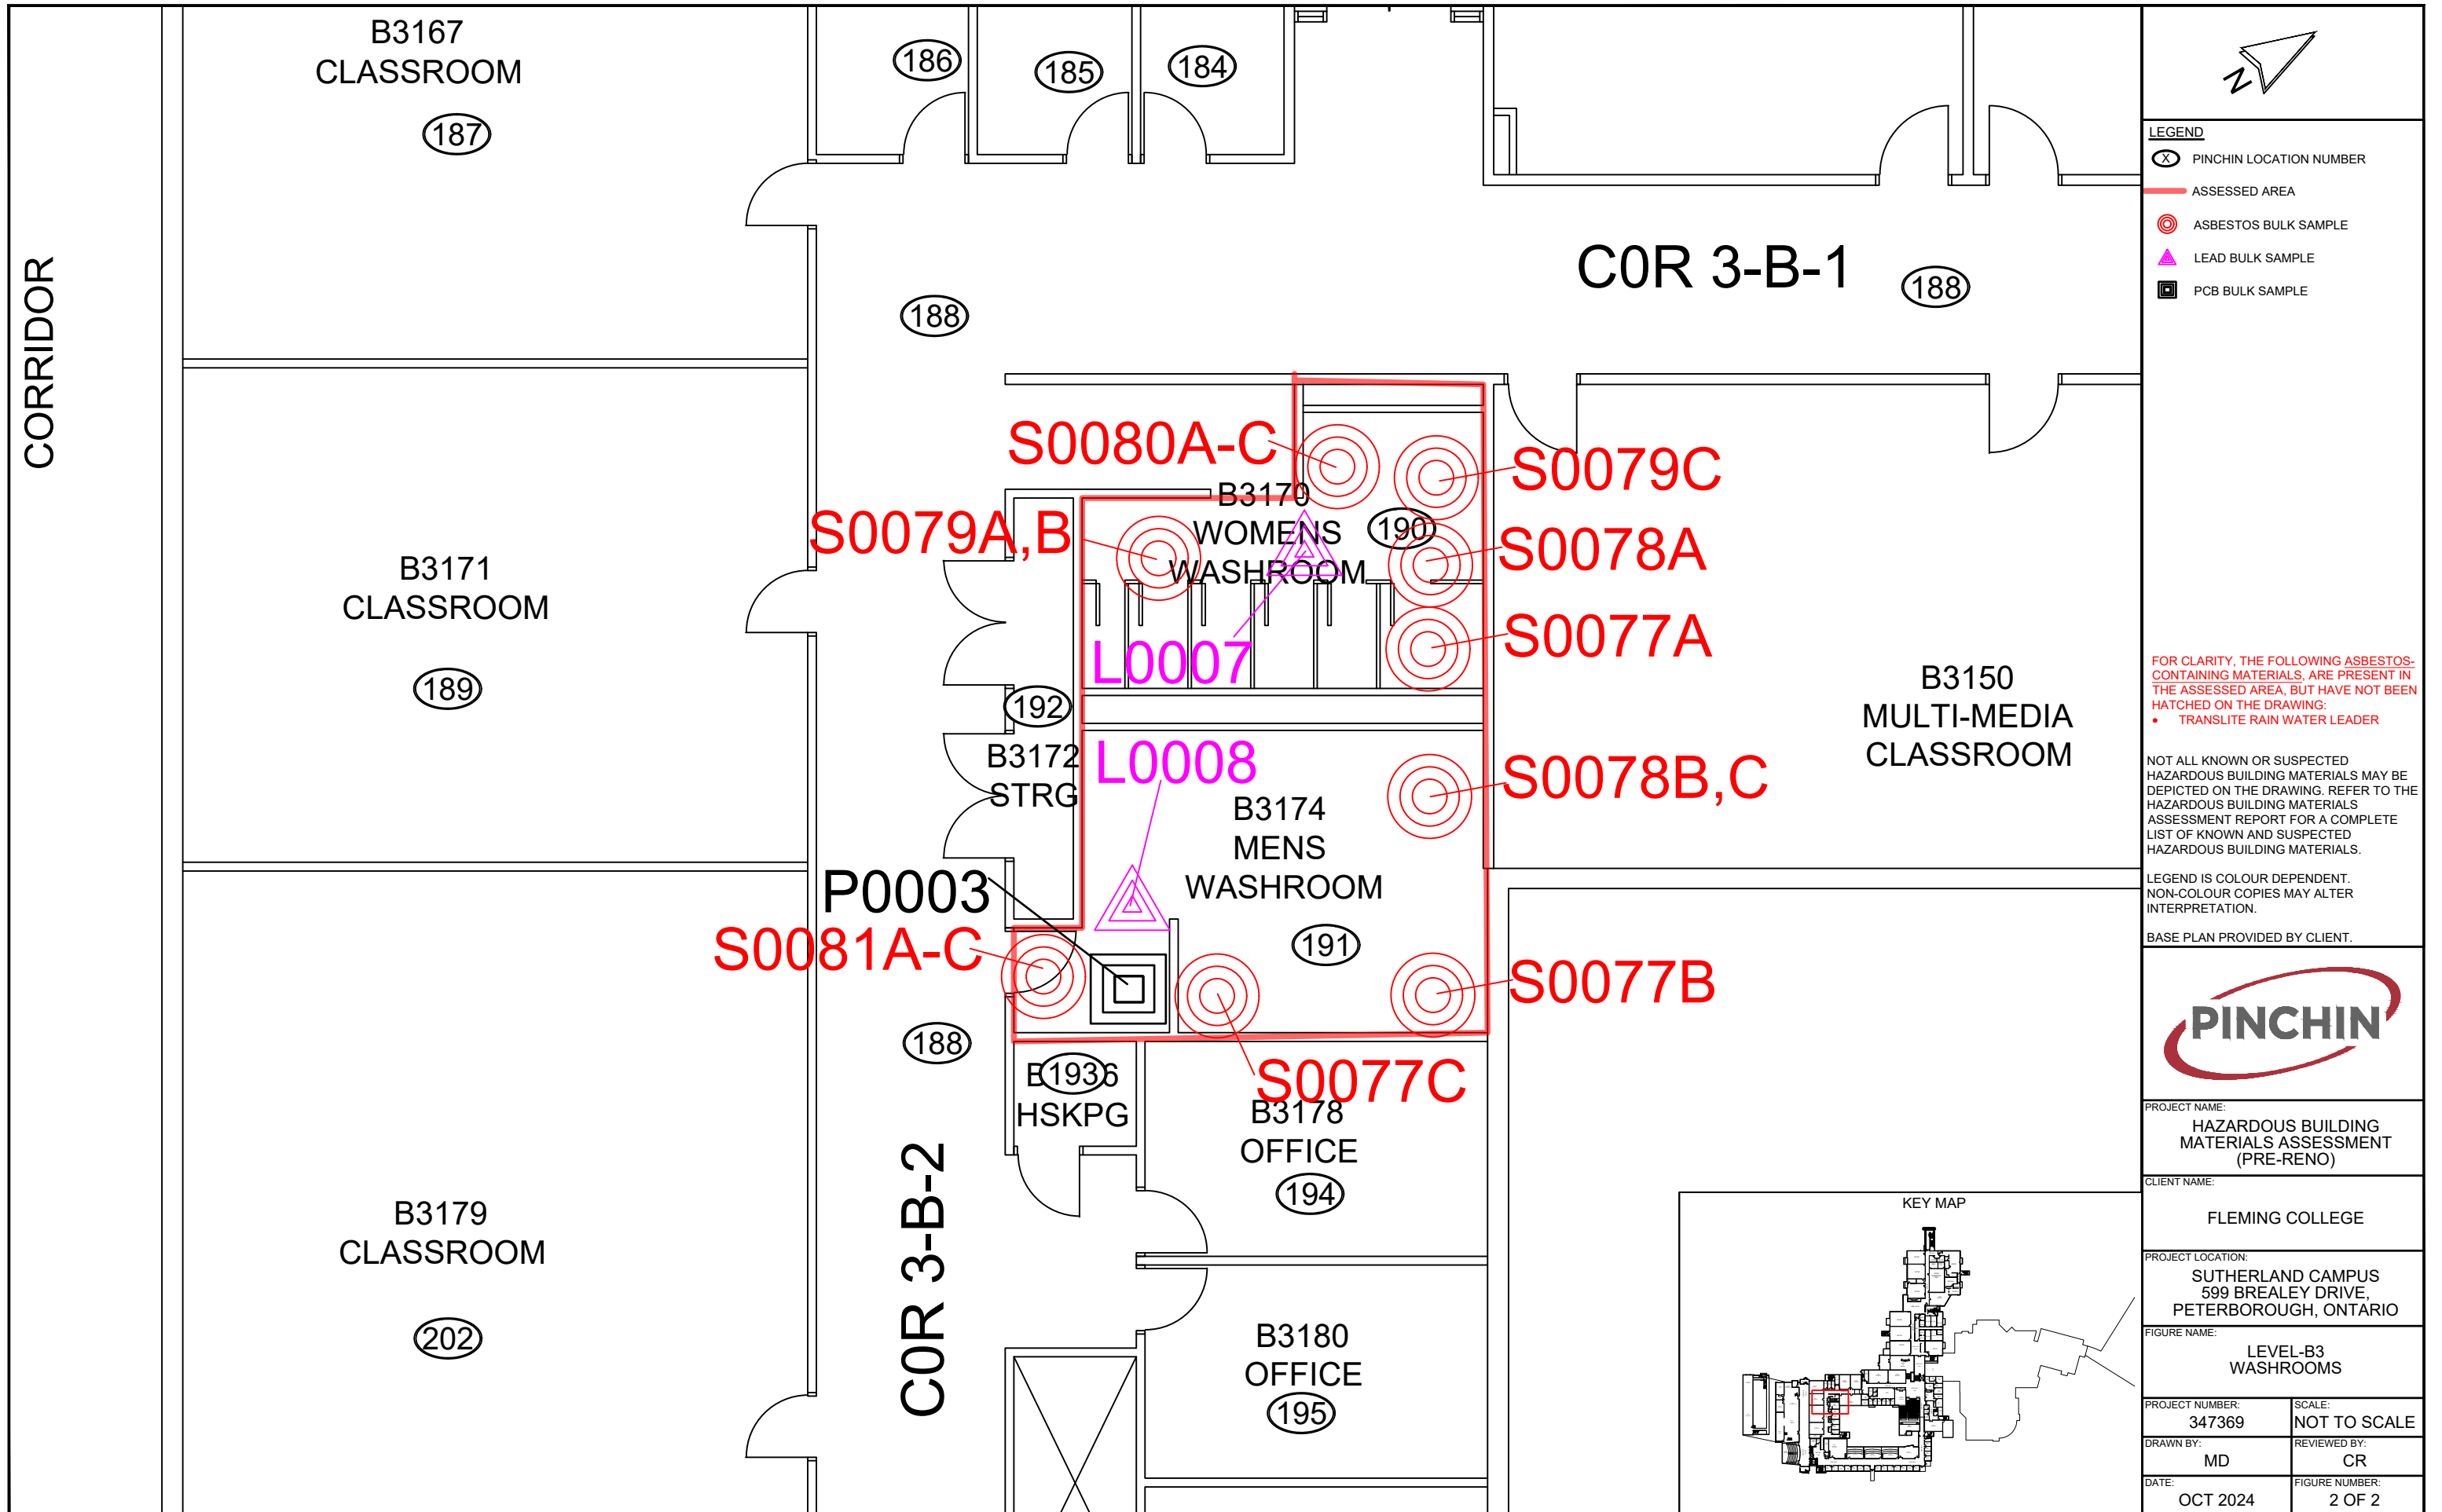
FIGURE NUMBER:
 2 OF 2

FOR CLARITY, THE FOLLOWING ASBESTOS-CONTAINING MATERIALS, ARE PRESENT IN THE ASSESSED AREA, BUT HAVE NOT BEEN HATCHED ON THE DRAWING:
 • TRANSLITE RAIN WATER LEADER

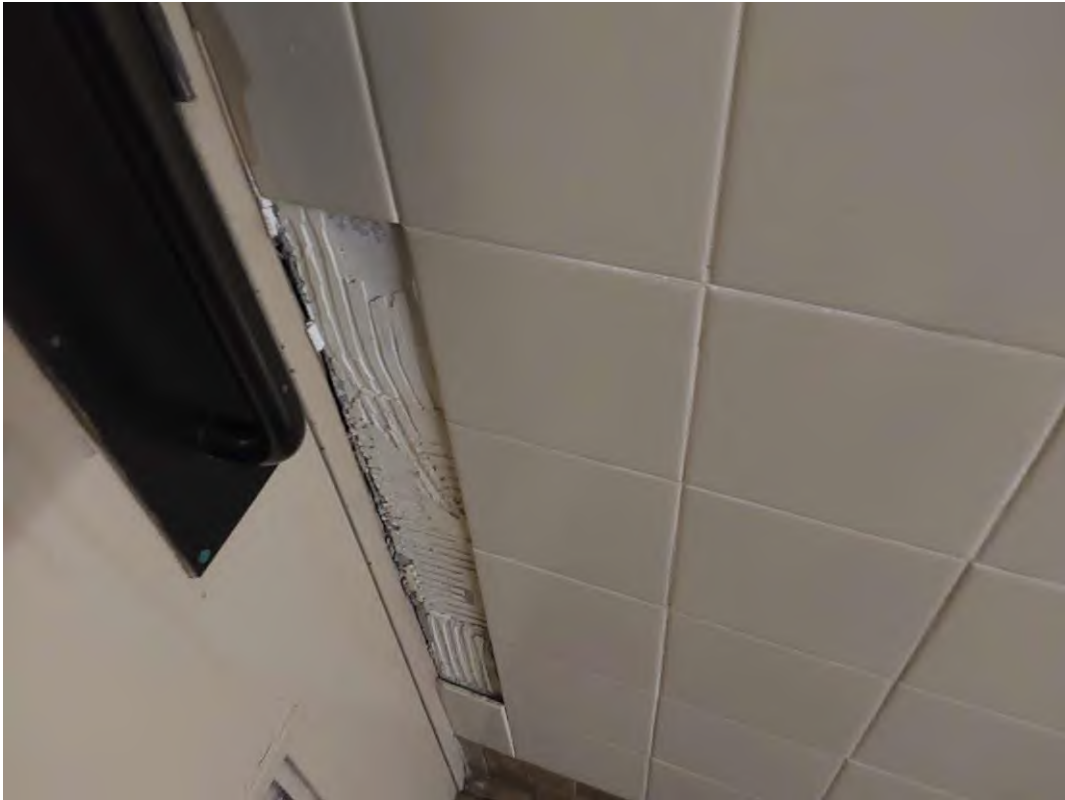
S0073A (None), Wall, Mortar, Women's Washroom - C2128 (Location #: 404)

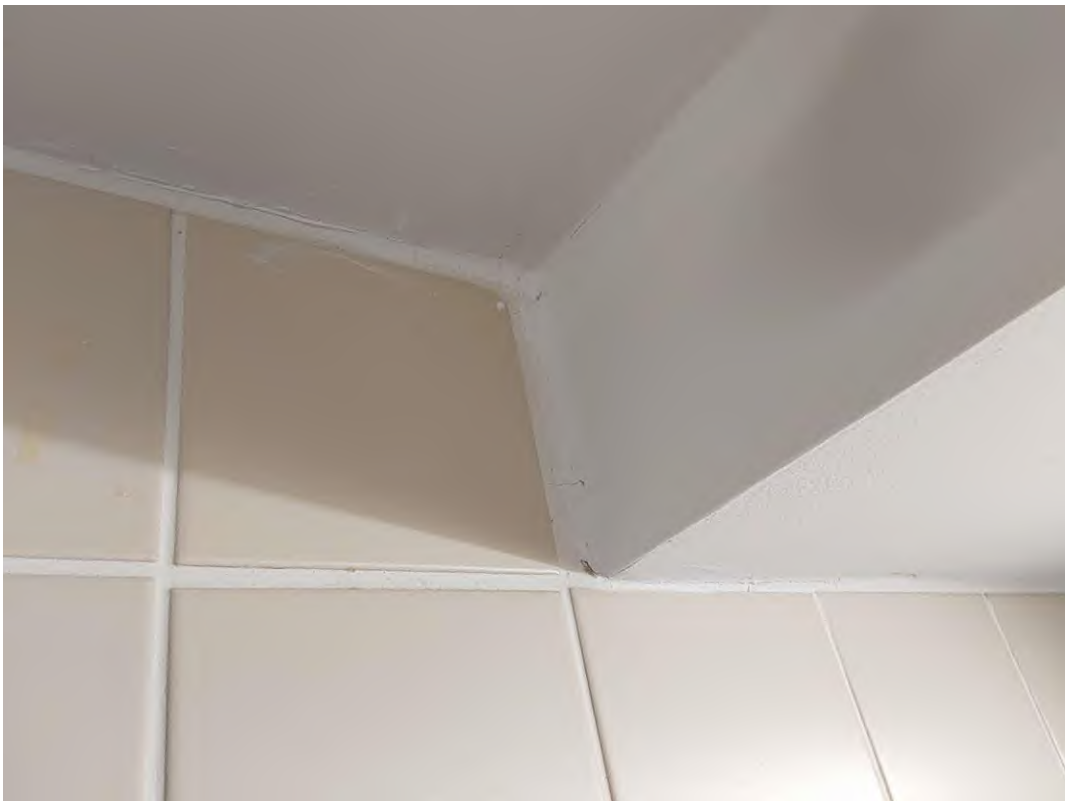
S0075A (None), White caulking along walls, Wall, Caulking, Women's Washroom - C2128 (Location #: 404)

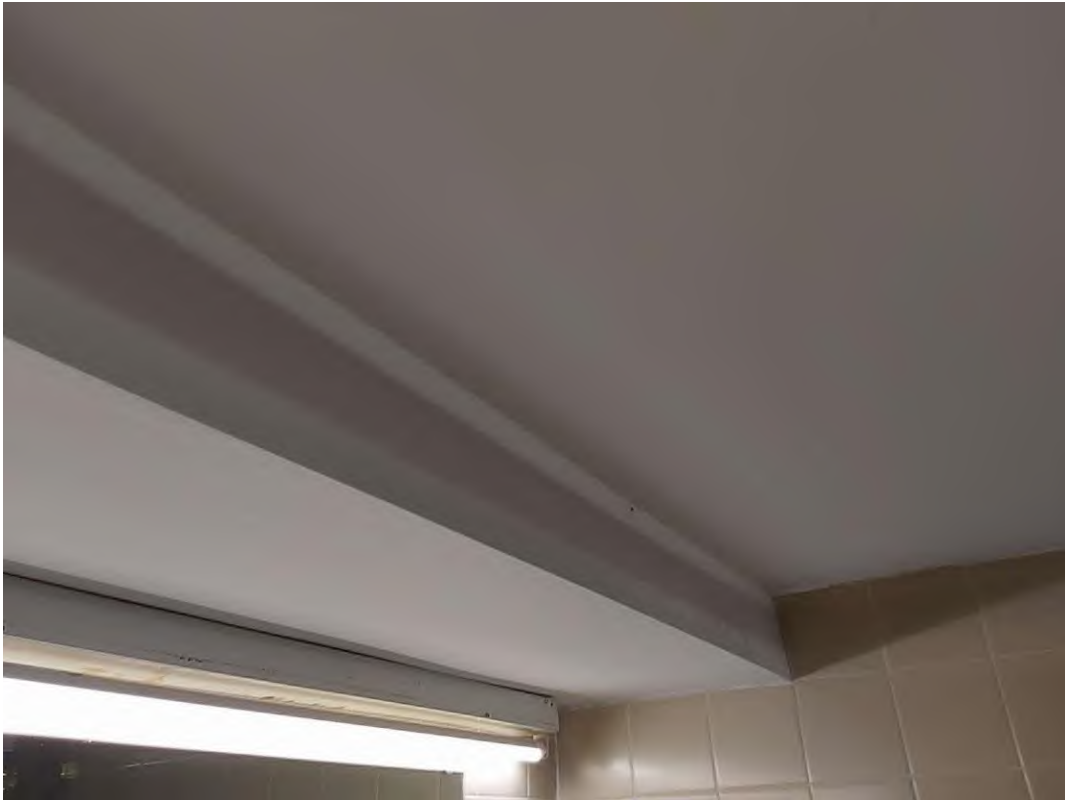
S0076C (None), Ceiling, Drywall and joint compound, Men's Washroom - C2126 (Location #: 403)

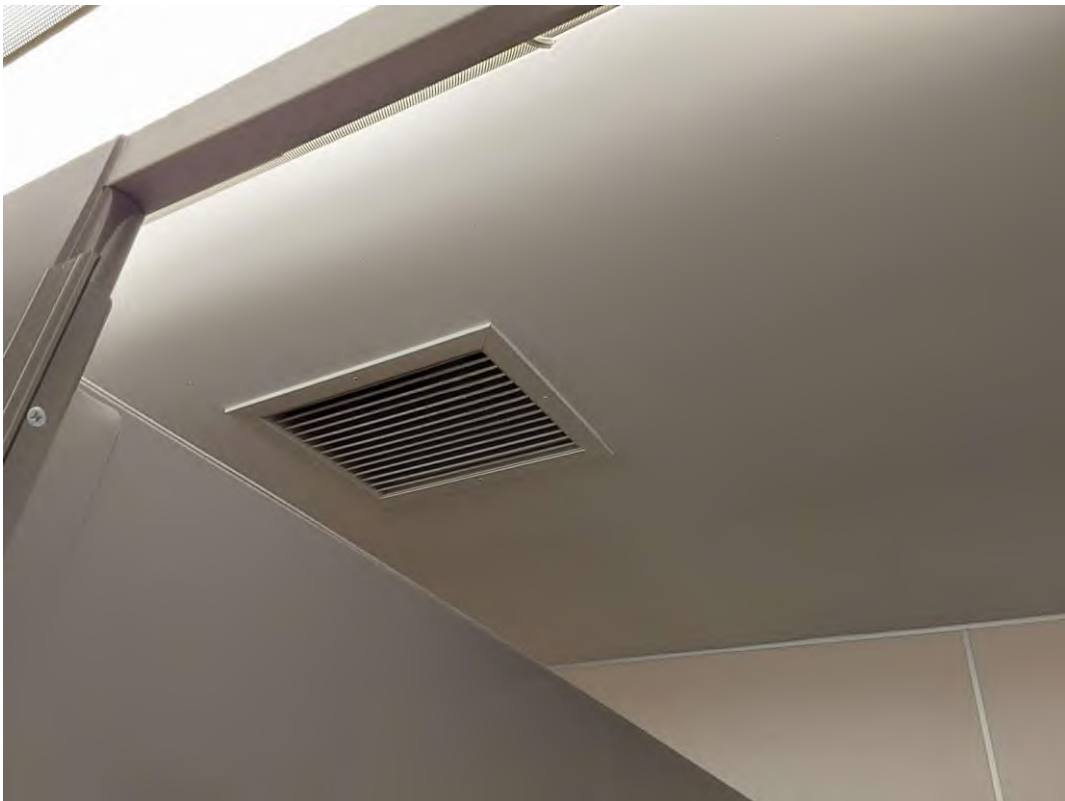
S0077A (None), Drywall on ceiling, Ceiling, Drywall and joint compound, Women's Washroom - B3170 (Location #: 190)

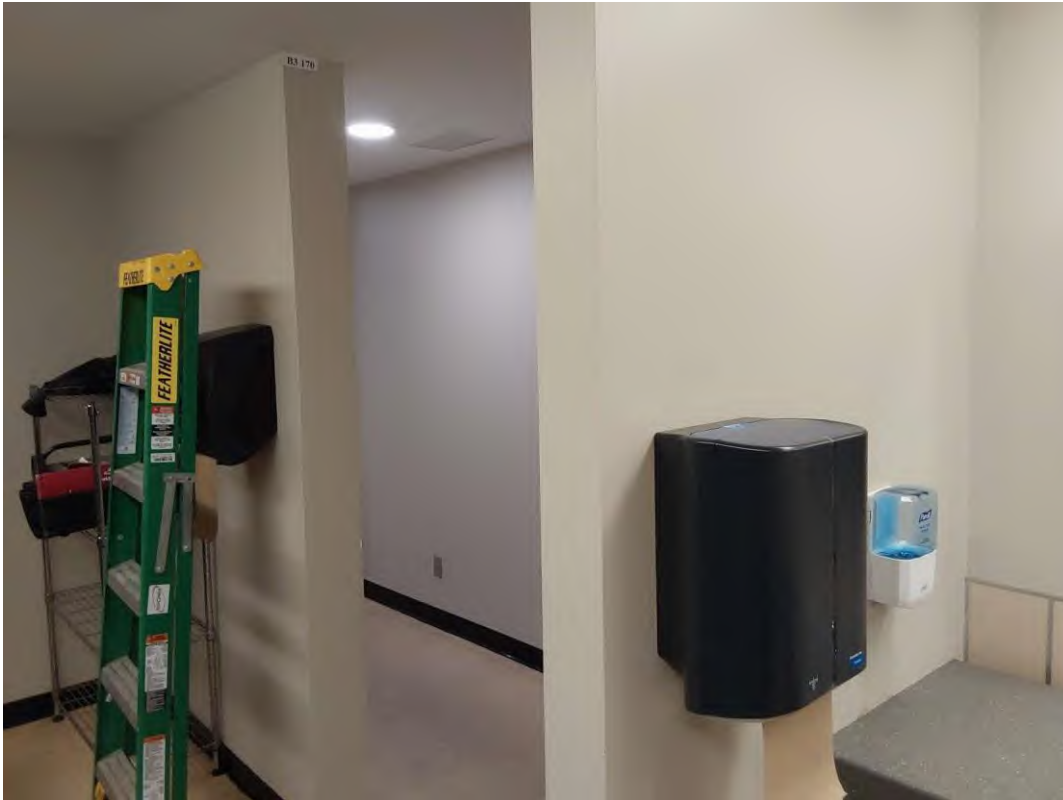
S0078A (None), Drywall on walls, Wall, Drywall and joint compound, Women's Washroom - B3170 (Location #: 190)

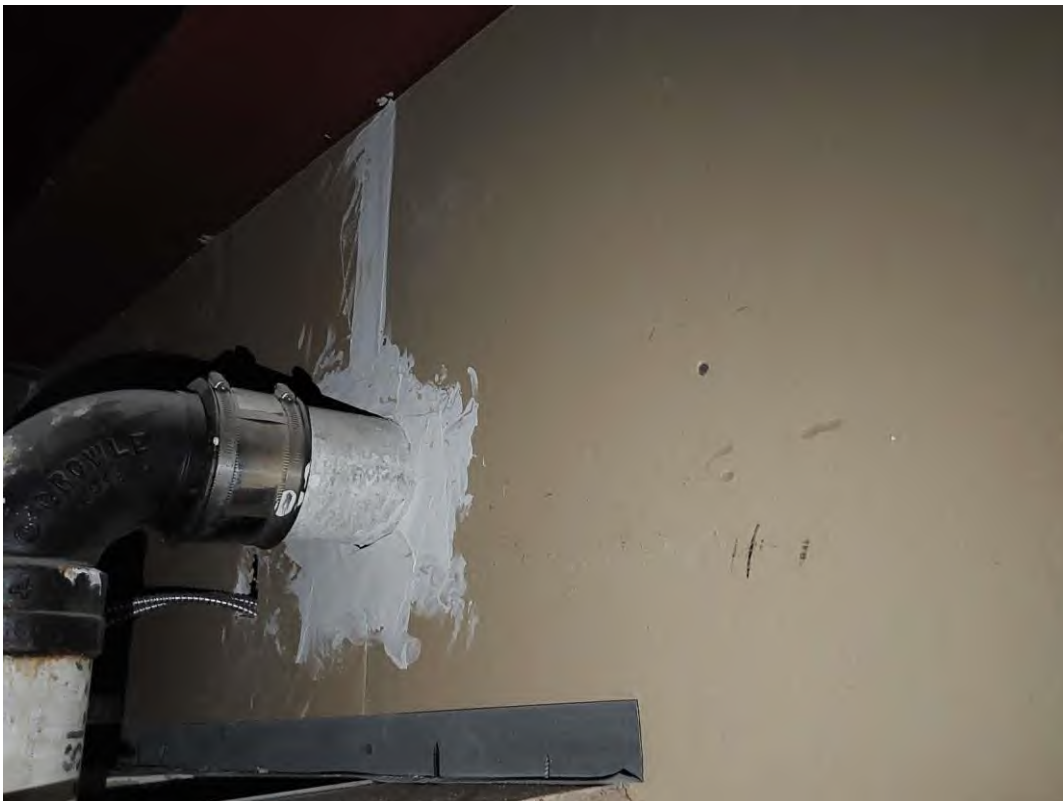
S0078B (None), Wall, Drywall and joint compound, Men's Washroom - B3174 (Location #: 191)

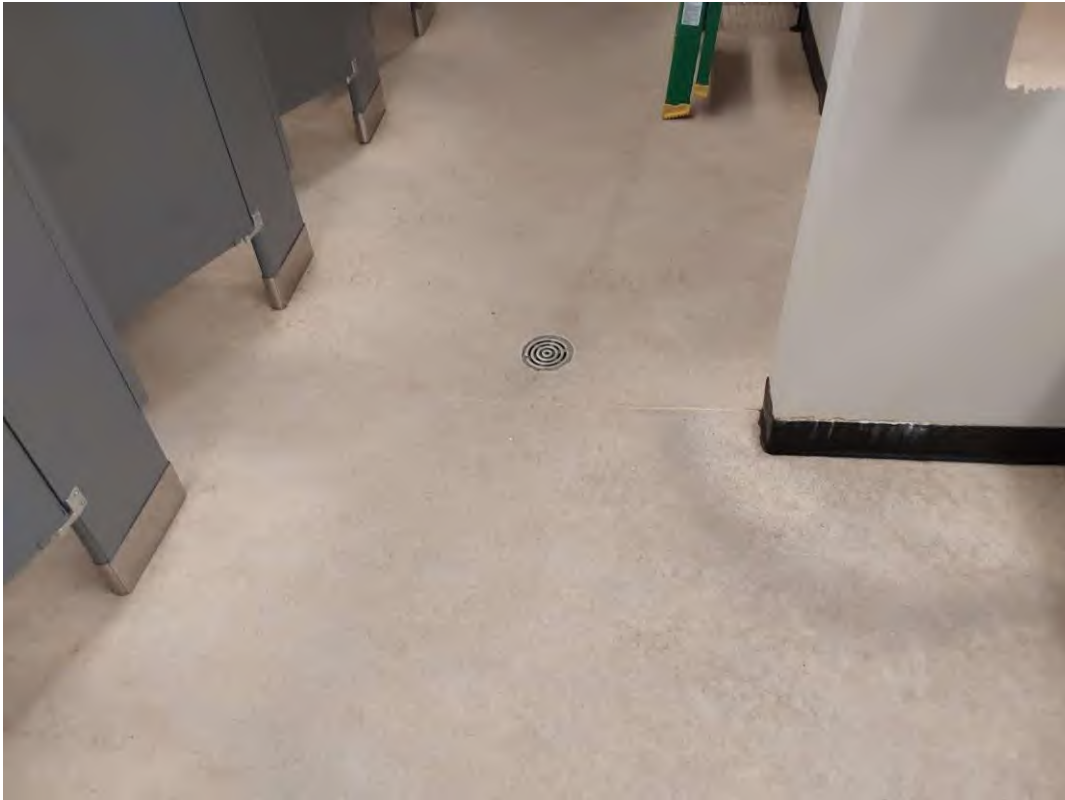
S0079C (None), Beige vinyl sheet flooring, Floor, Vinyl Sheet Flooring, Women's Washroom - B3170 (Location #: 190)

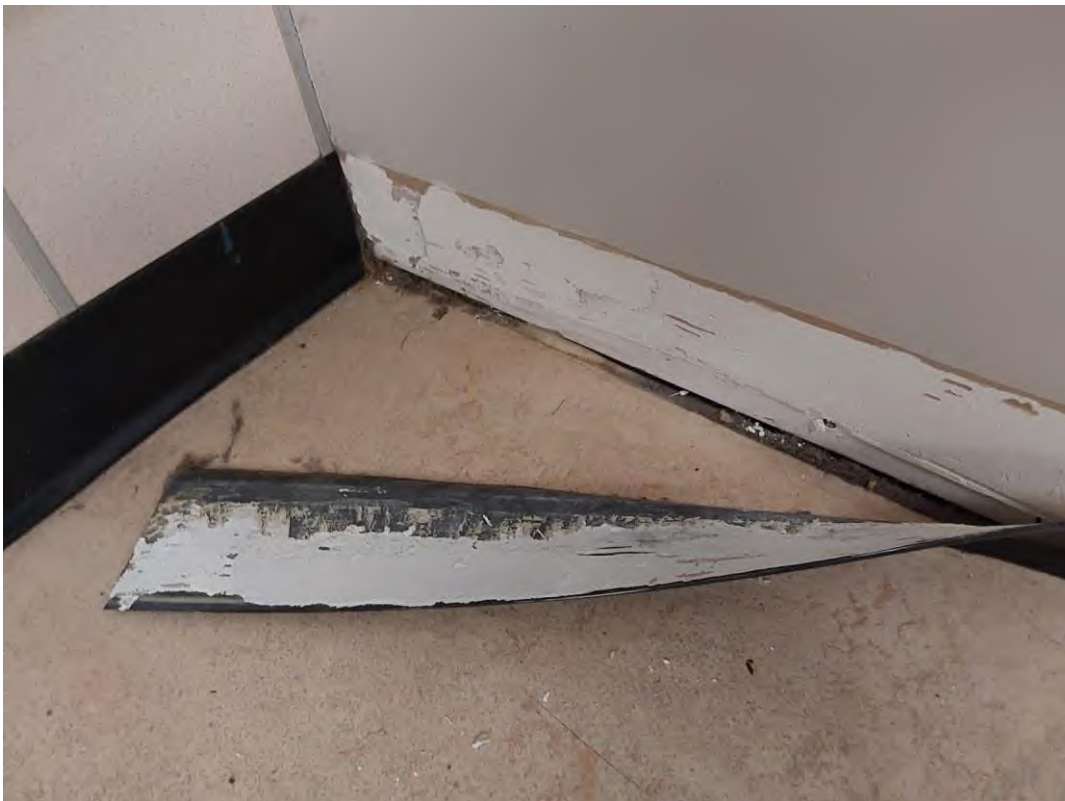
S0080C (None), Beige baseboard mastic, Wall, Adhesive/mastic, Women's Washroom - B3170 (Location #: 190)

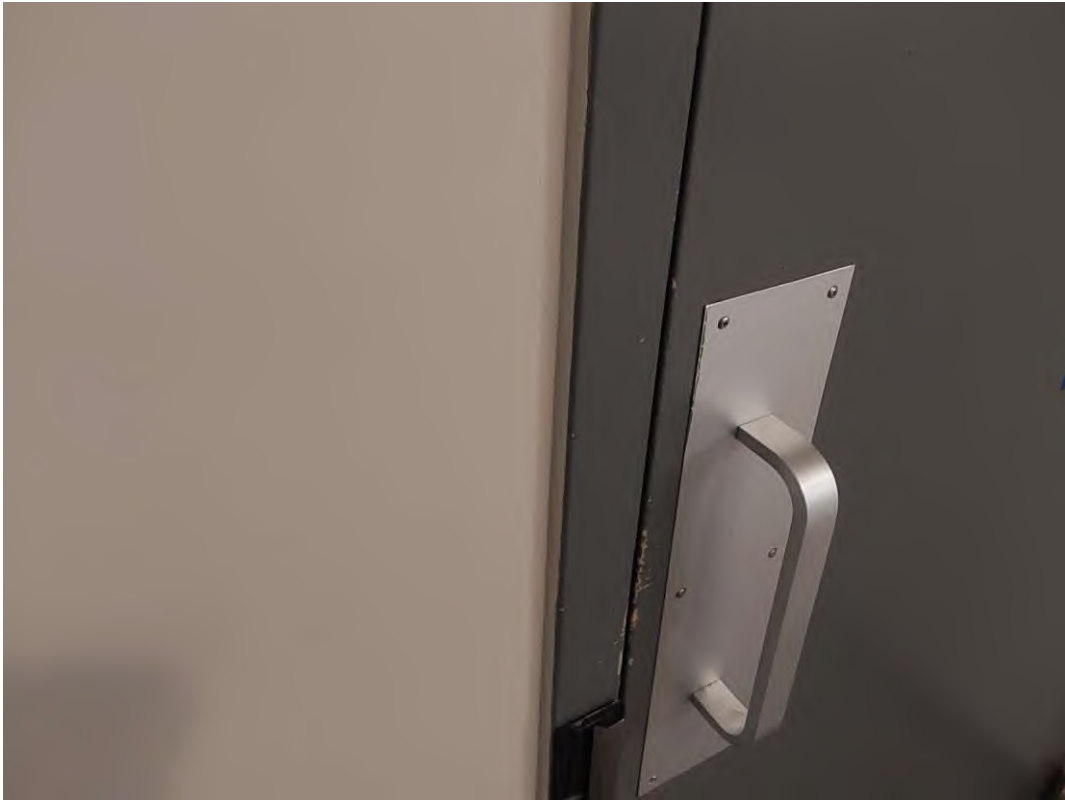
S0081C (None), Beige caulking on door frame, Wall, Caulking, Men's Washroom - B3174 (Location #: 191)

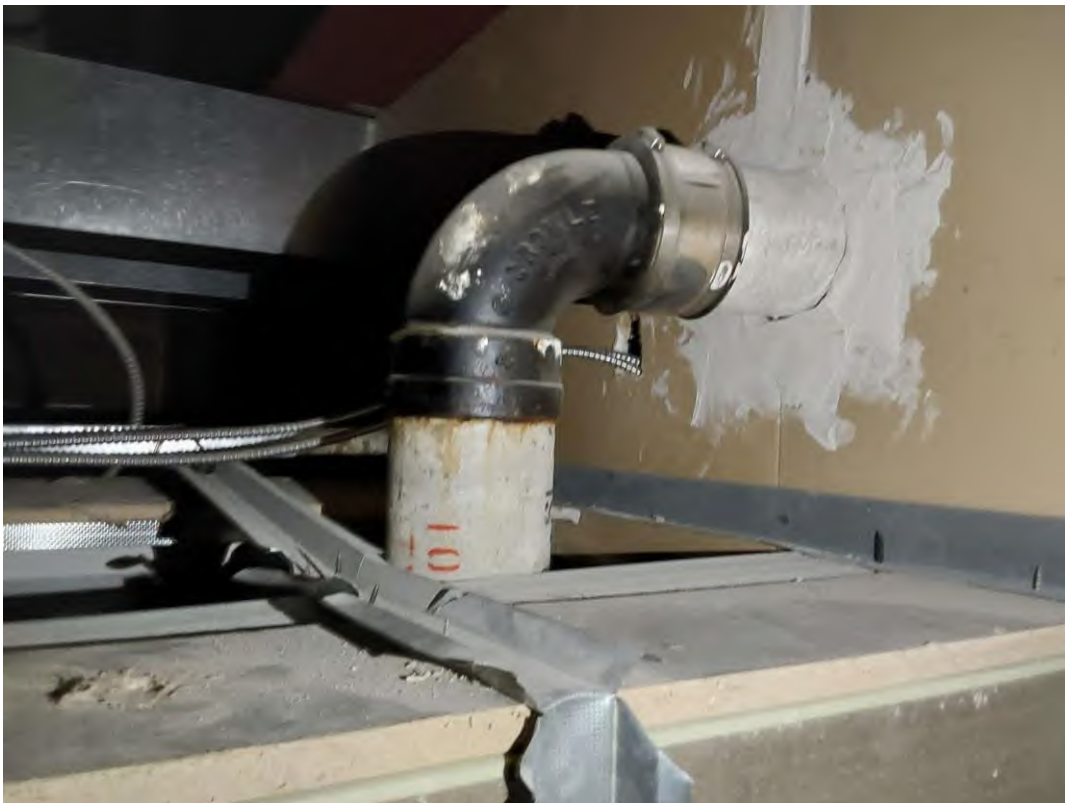
V9000 (Confirmed Asbestos), Piping, Drain, Cement Product, Men's Washroom - B3174 (Location #: 191)
Near ceiling hatch

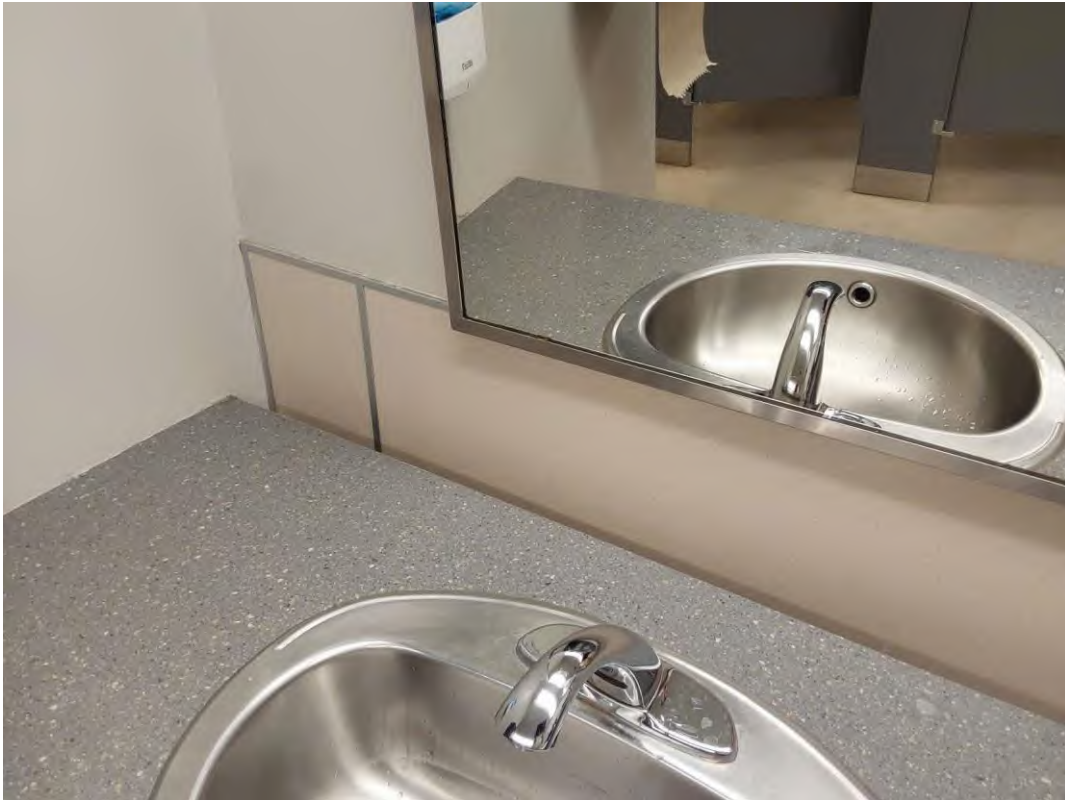
Wall, Plastic, Women's Washroom - B3170 (Location #: 190)
Plastic board, adhered with drywall compound and caulking

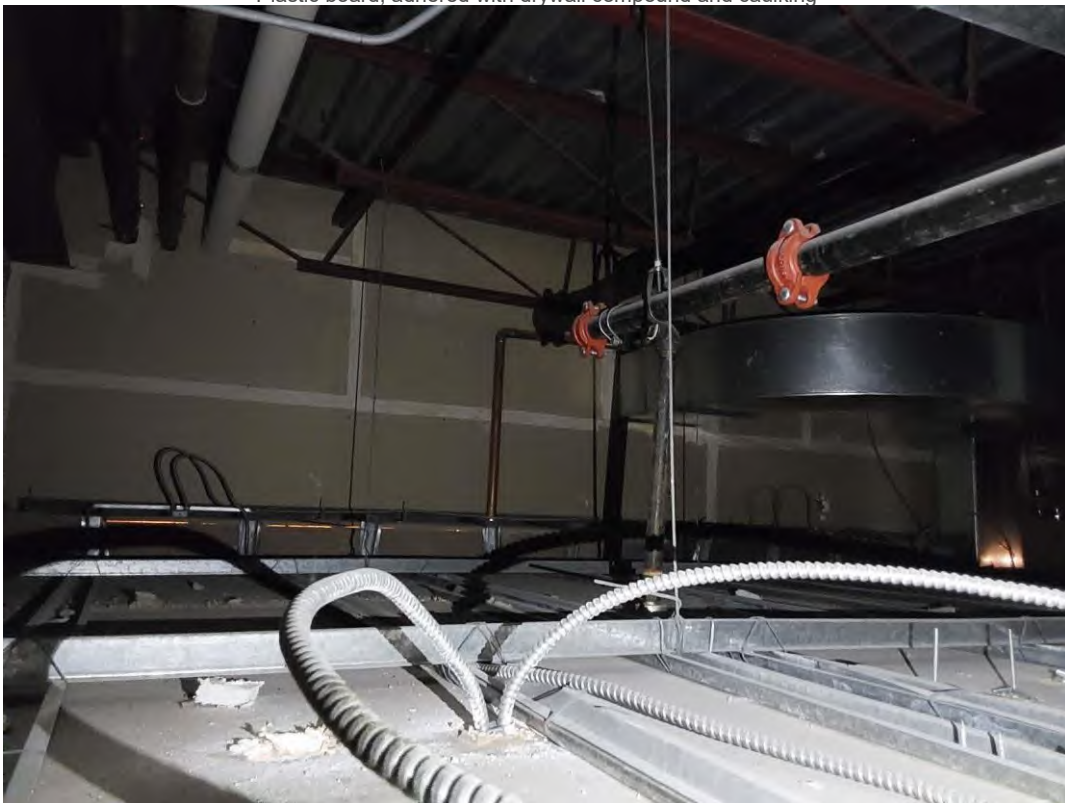
Piping, Not Insulated, Men's Washroom - B3174 (Location #: 191)

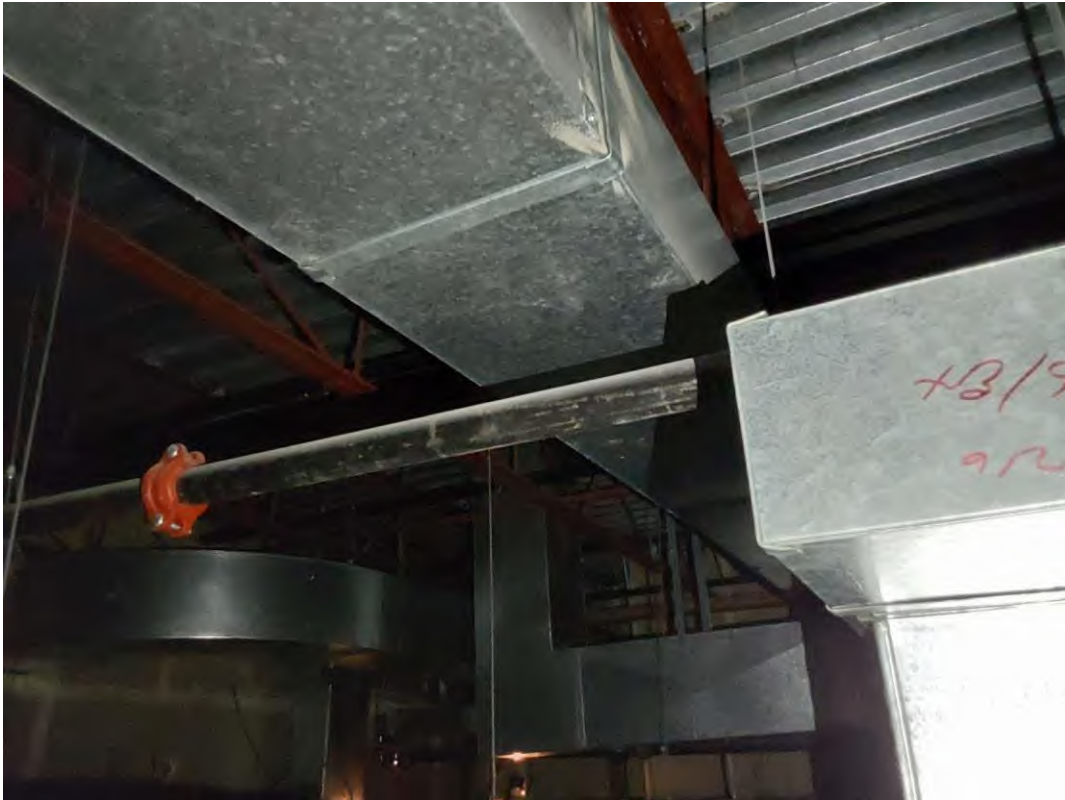
Duct, Not Insulated, Men's Washroom - B3174 (Location #: 191)

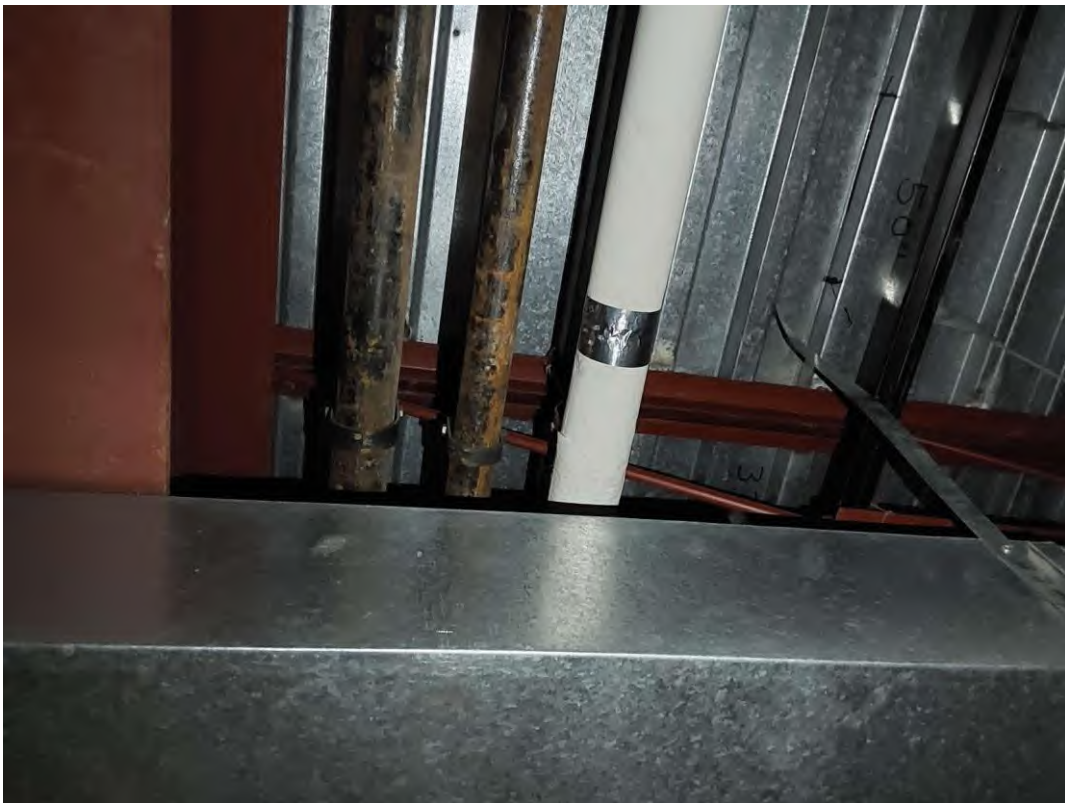
Piping, Fibreglass, Men's Washroom - B3174 (Location #: 191)

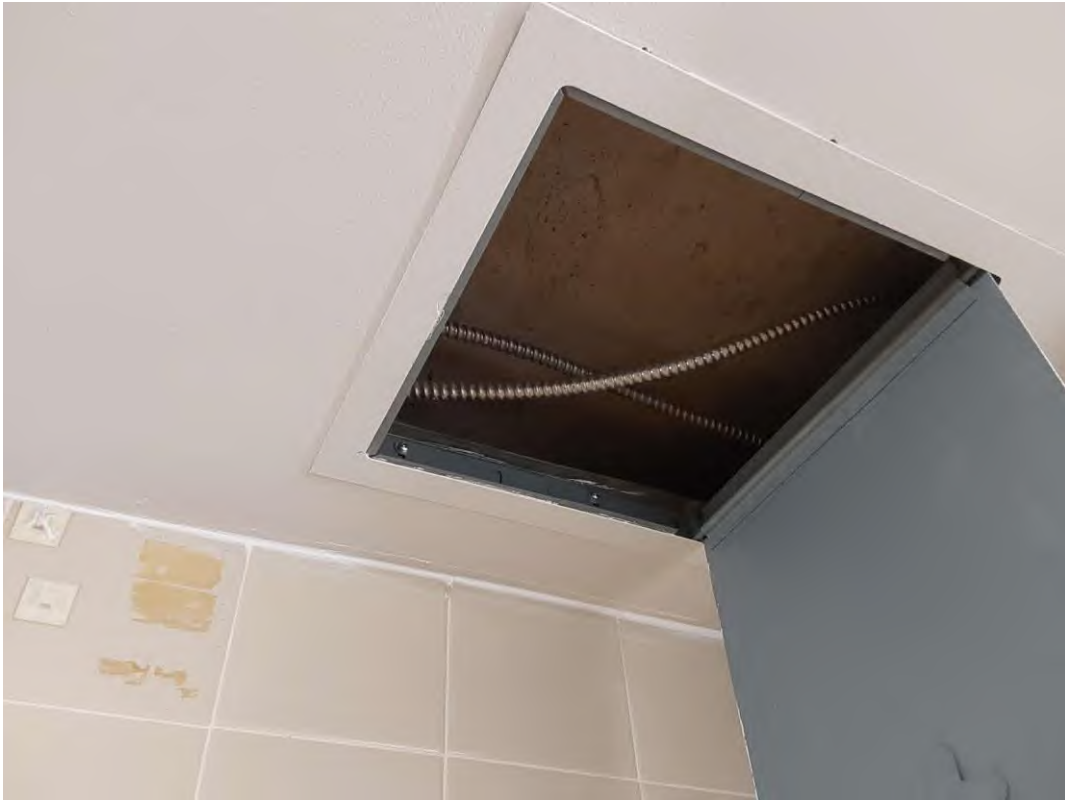
Structure, Concrete (poured), Men's Washroom - C2126 (Location #: 403)

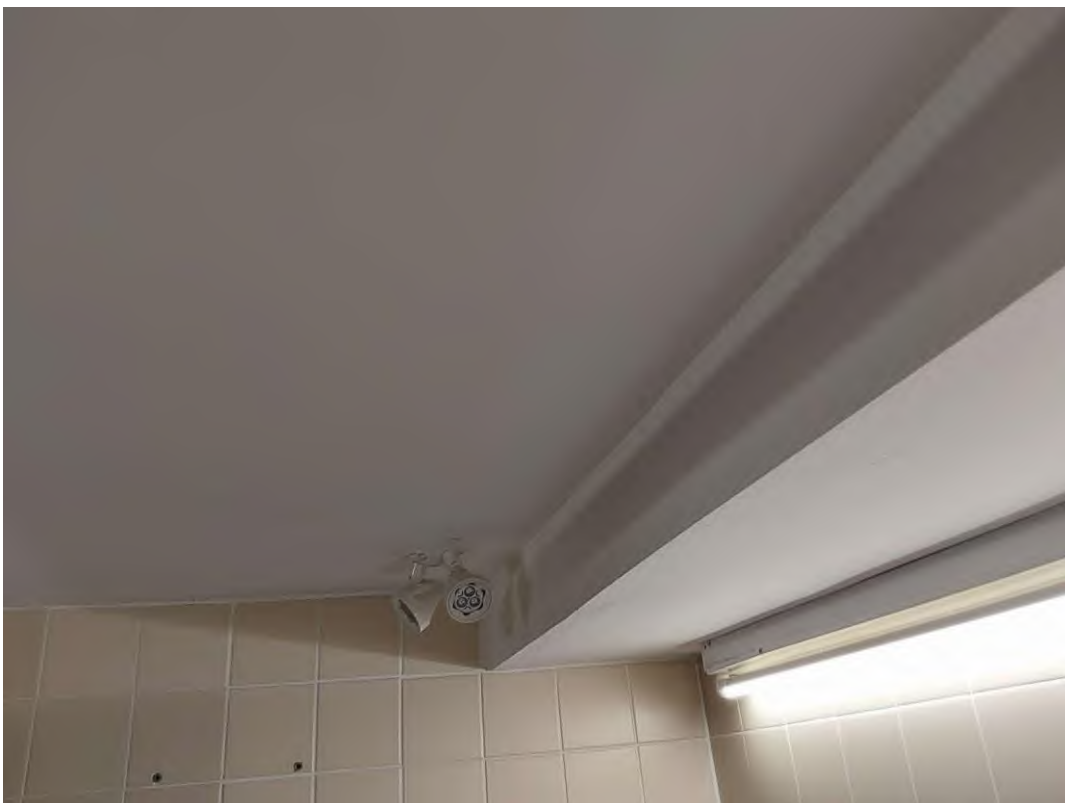
L0005(Lead, None), White paint on drywall, Ceiling, Men's Washroom - C2126 (Location #: 403)

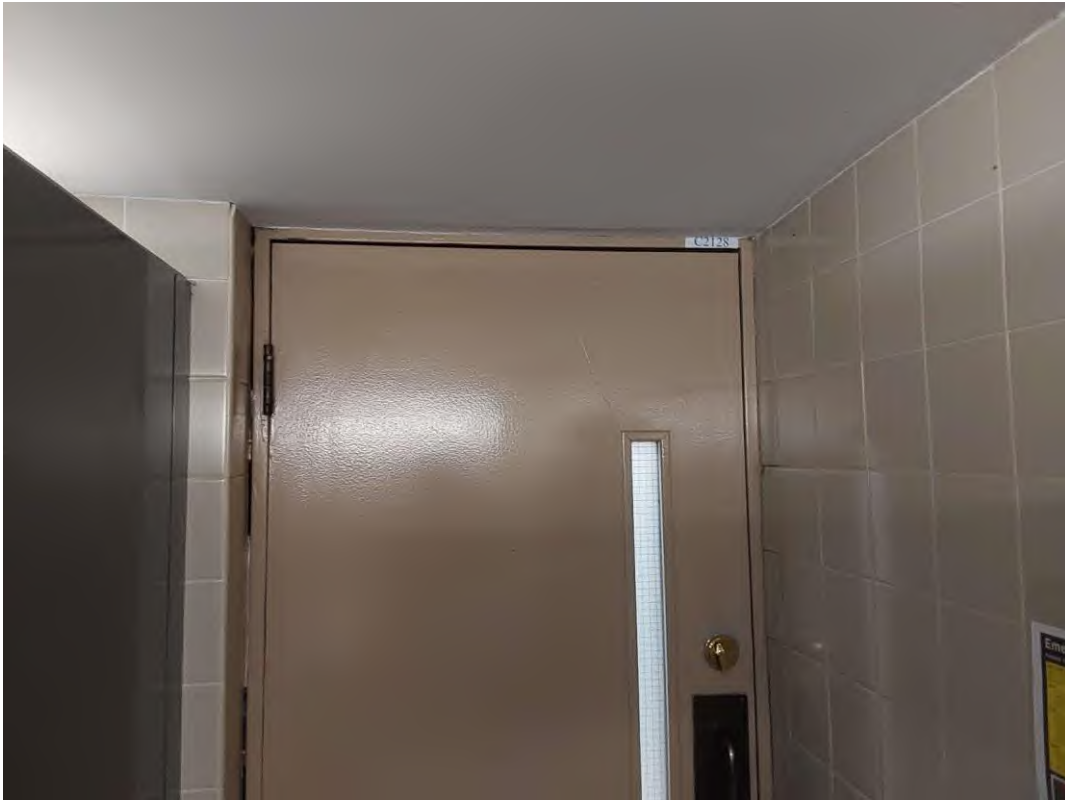
L0006(Lead, None), Beige paint on door, Wall, Men's Washroom - C2126 (Location #: 403)

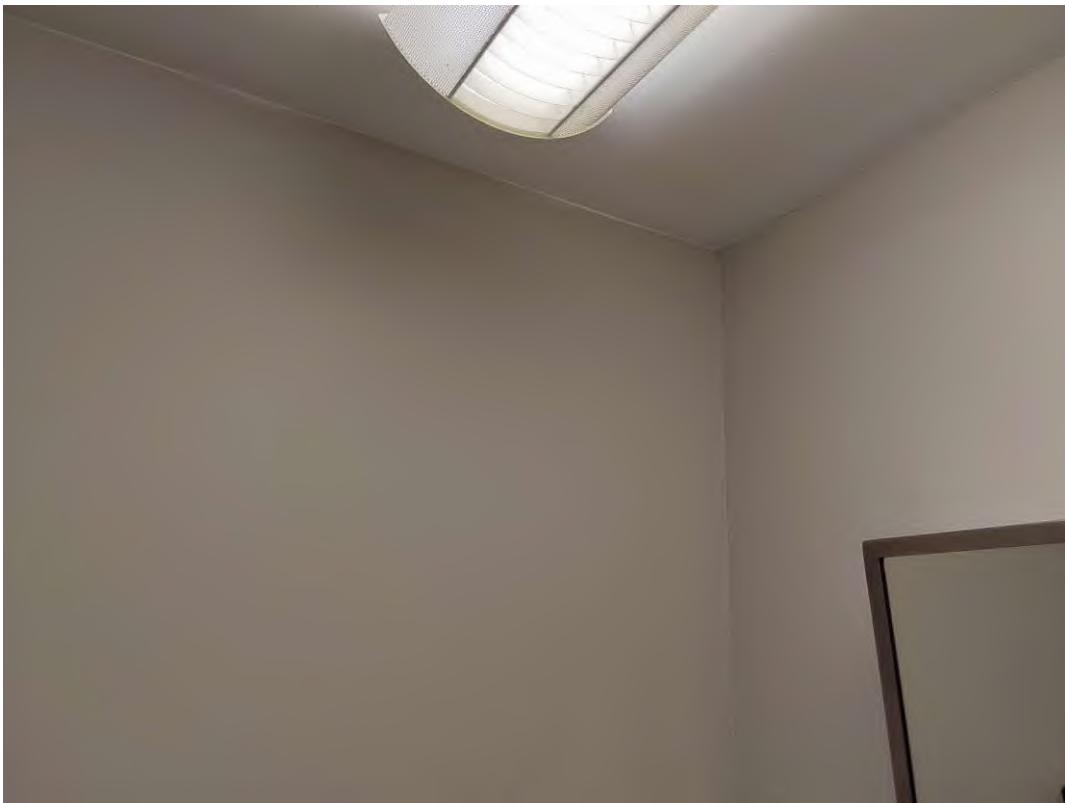
L0007(Lead, None), Off-white paint on drywall, Wall, Women's Washroom - B3170 (Location #: 190)

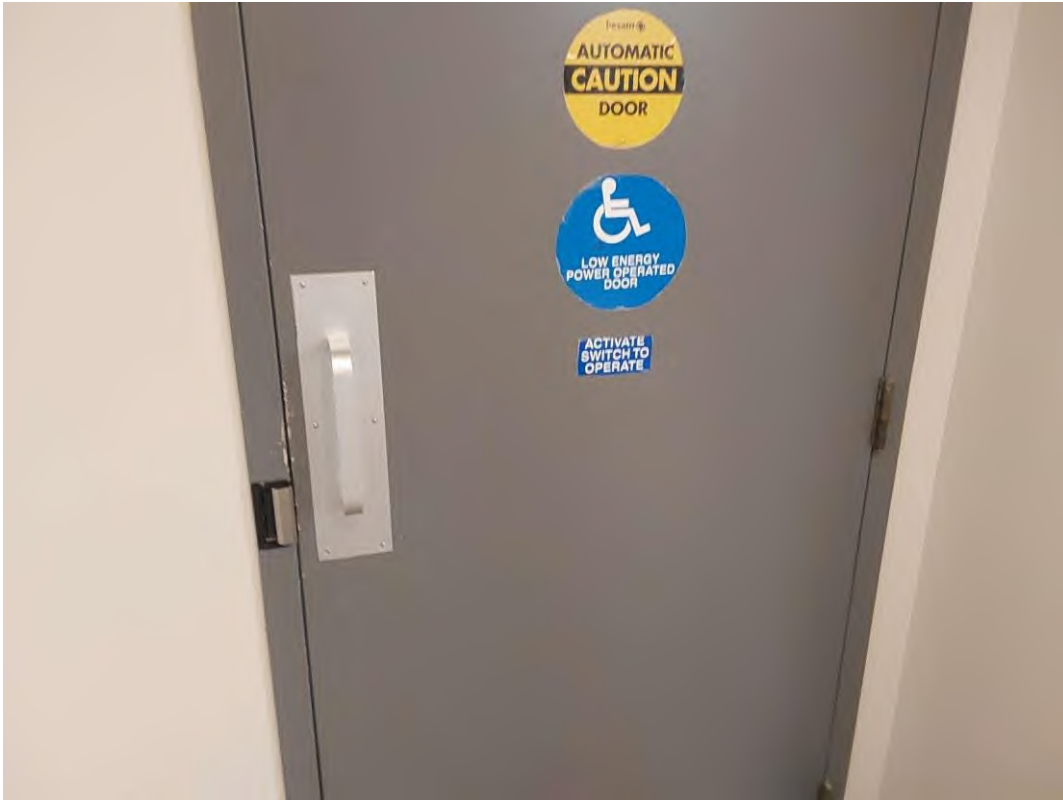
L0008(Lead, Low), Grey paint on door, Wall, Men's Washroom - B3174 (Location #: 191)

For paints identified as having low levels of lead (i.e., equal to or above 0.009% (90 mg/kg) but less than or equal to the EACC guideline of 0.1% (1,000 mg/kg) for lead-containing paints) special precautions are not recommended unless aggressive disturbance (grinding, blasting, torching) is planned.

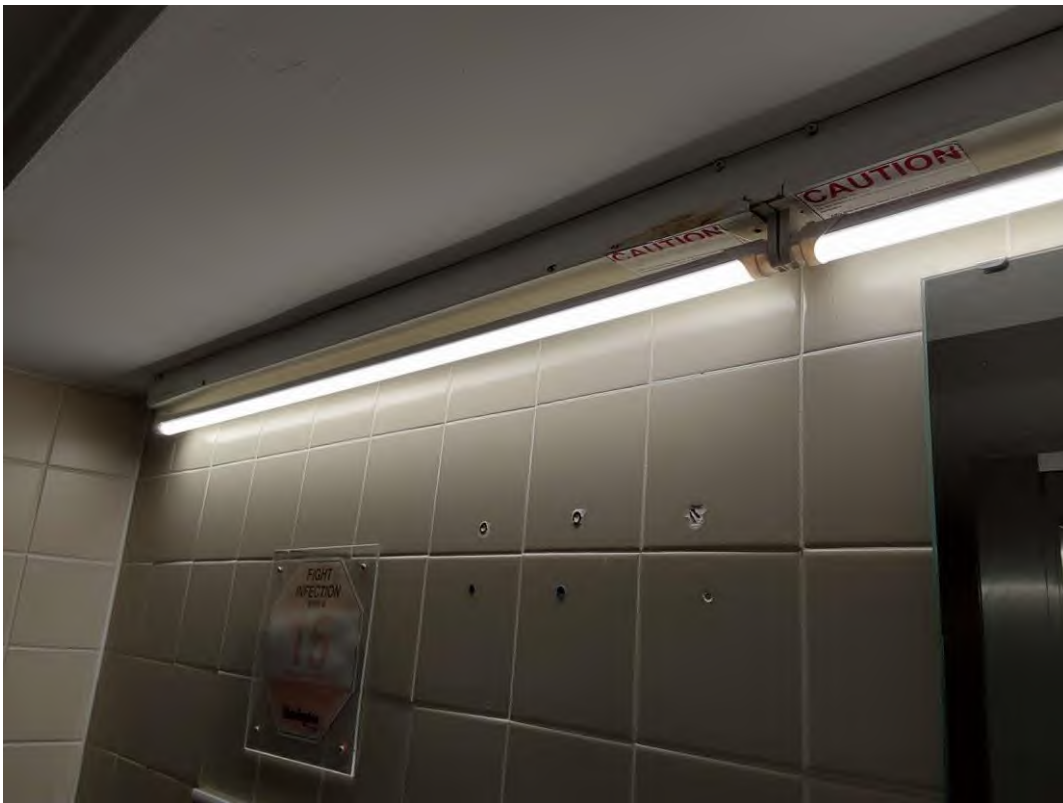
Mercury, V0000(No), LIGHT FIXTURE, LED, Men's Washroom - C2126 (Location #: 403)
