Hazardous Building Materials Assessment (Pre-construction)

Sutherland Campus, Main Building
599 Brealey Drive, Peterborough

October 18, 2024

Pinchin File: 347369

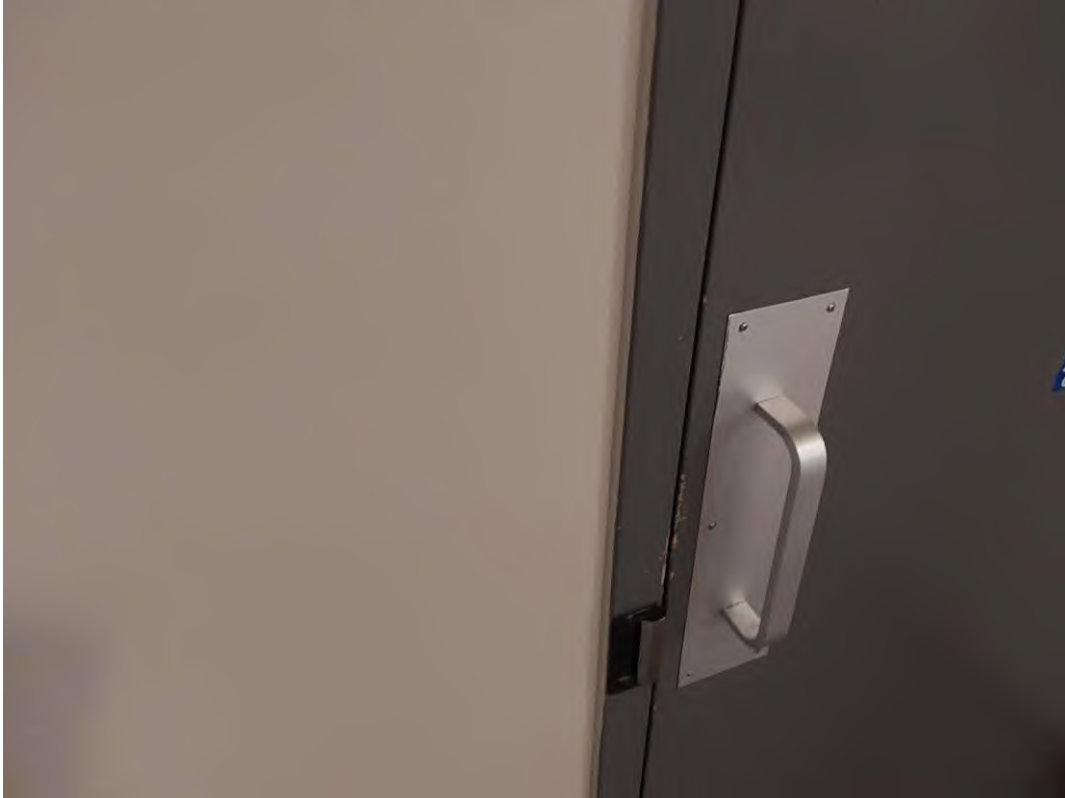
PCB, P0003(No), CAULKING, Beige caulking on door frame, Men's Washroom - B3174 (Location #: 191)

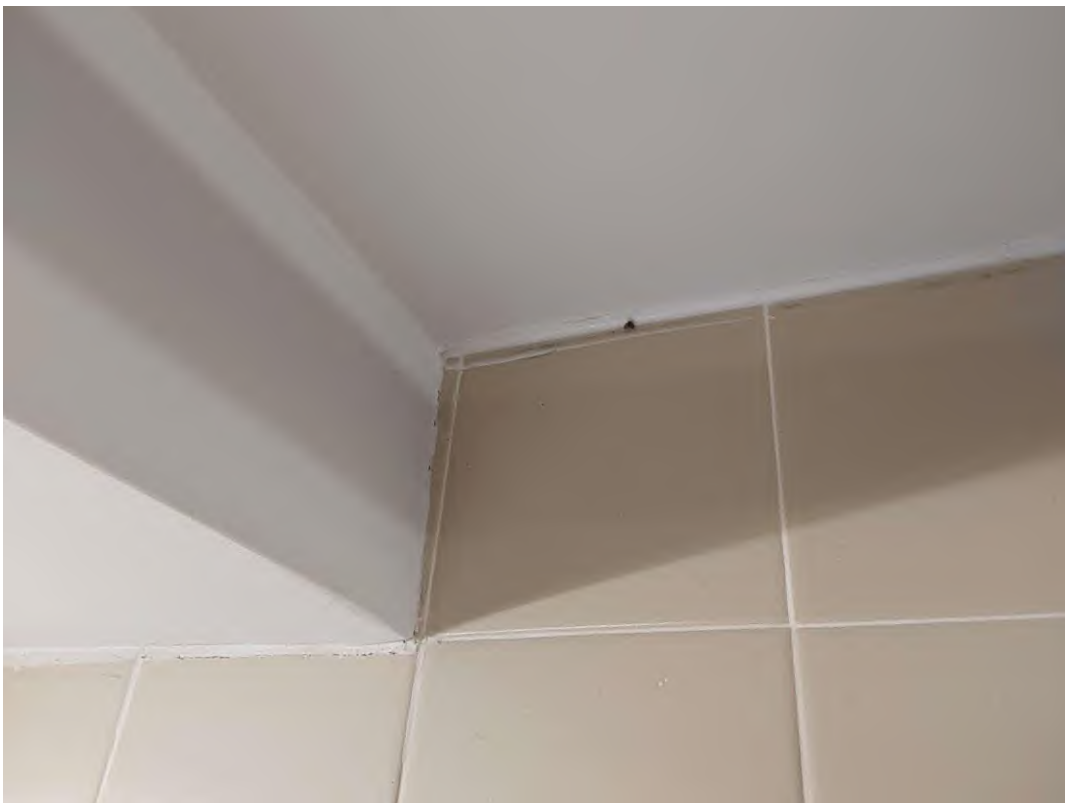
PCB, P0002(No), CAULKING, White caulking along walls, Men's Washroom - C2126 (Location #: 403)
