Hazardous Building Materials Assessment (Pre-construction)

Sutherland Campus, Main Building
599 Brealey Drive, Peterborough

October 18, 2024

Pinchin File: 347369

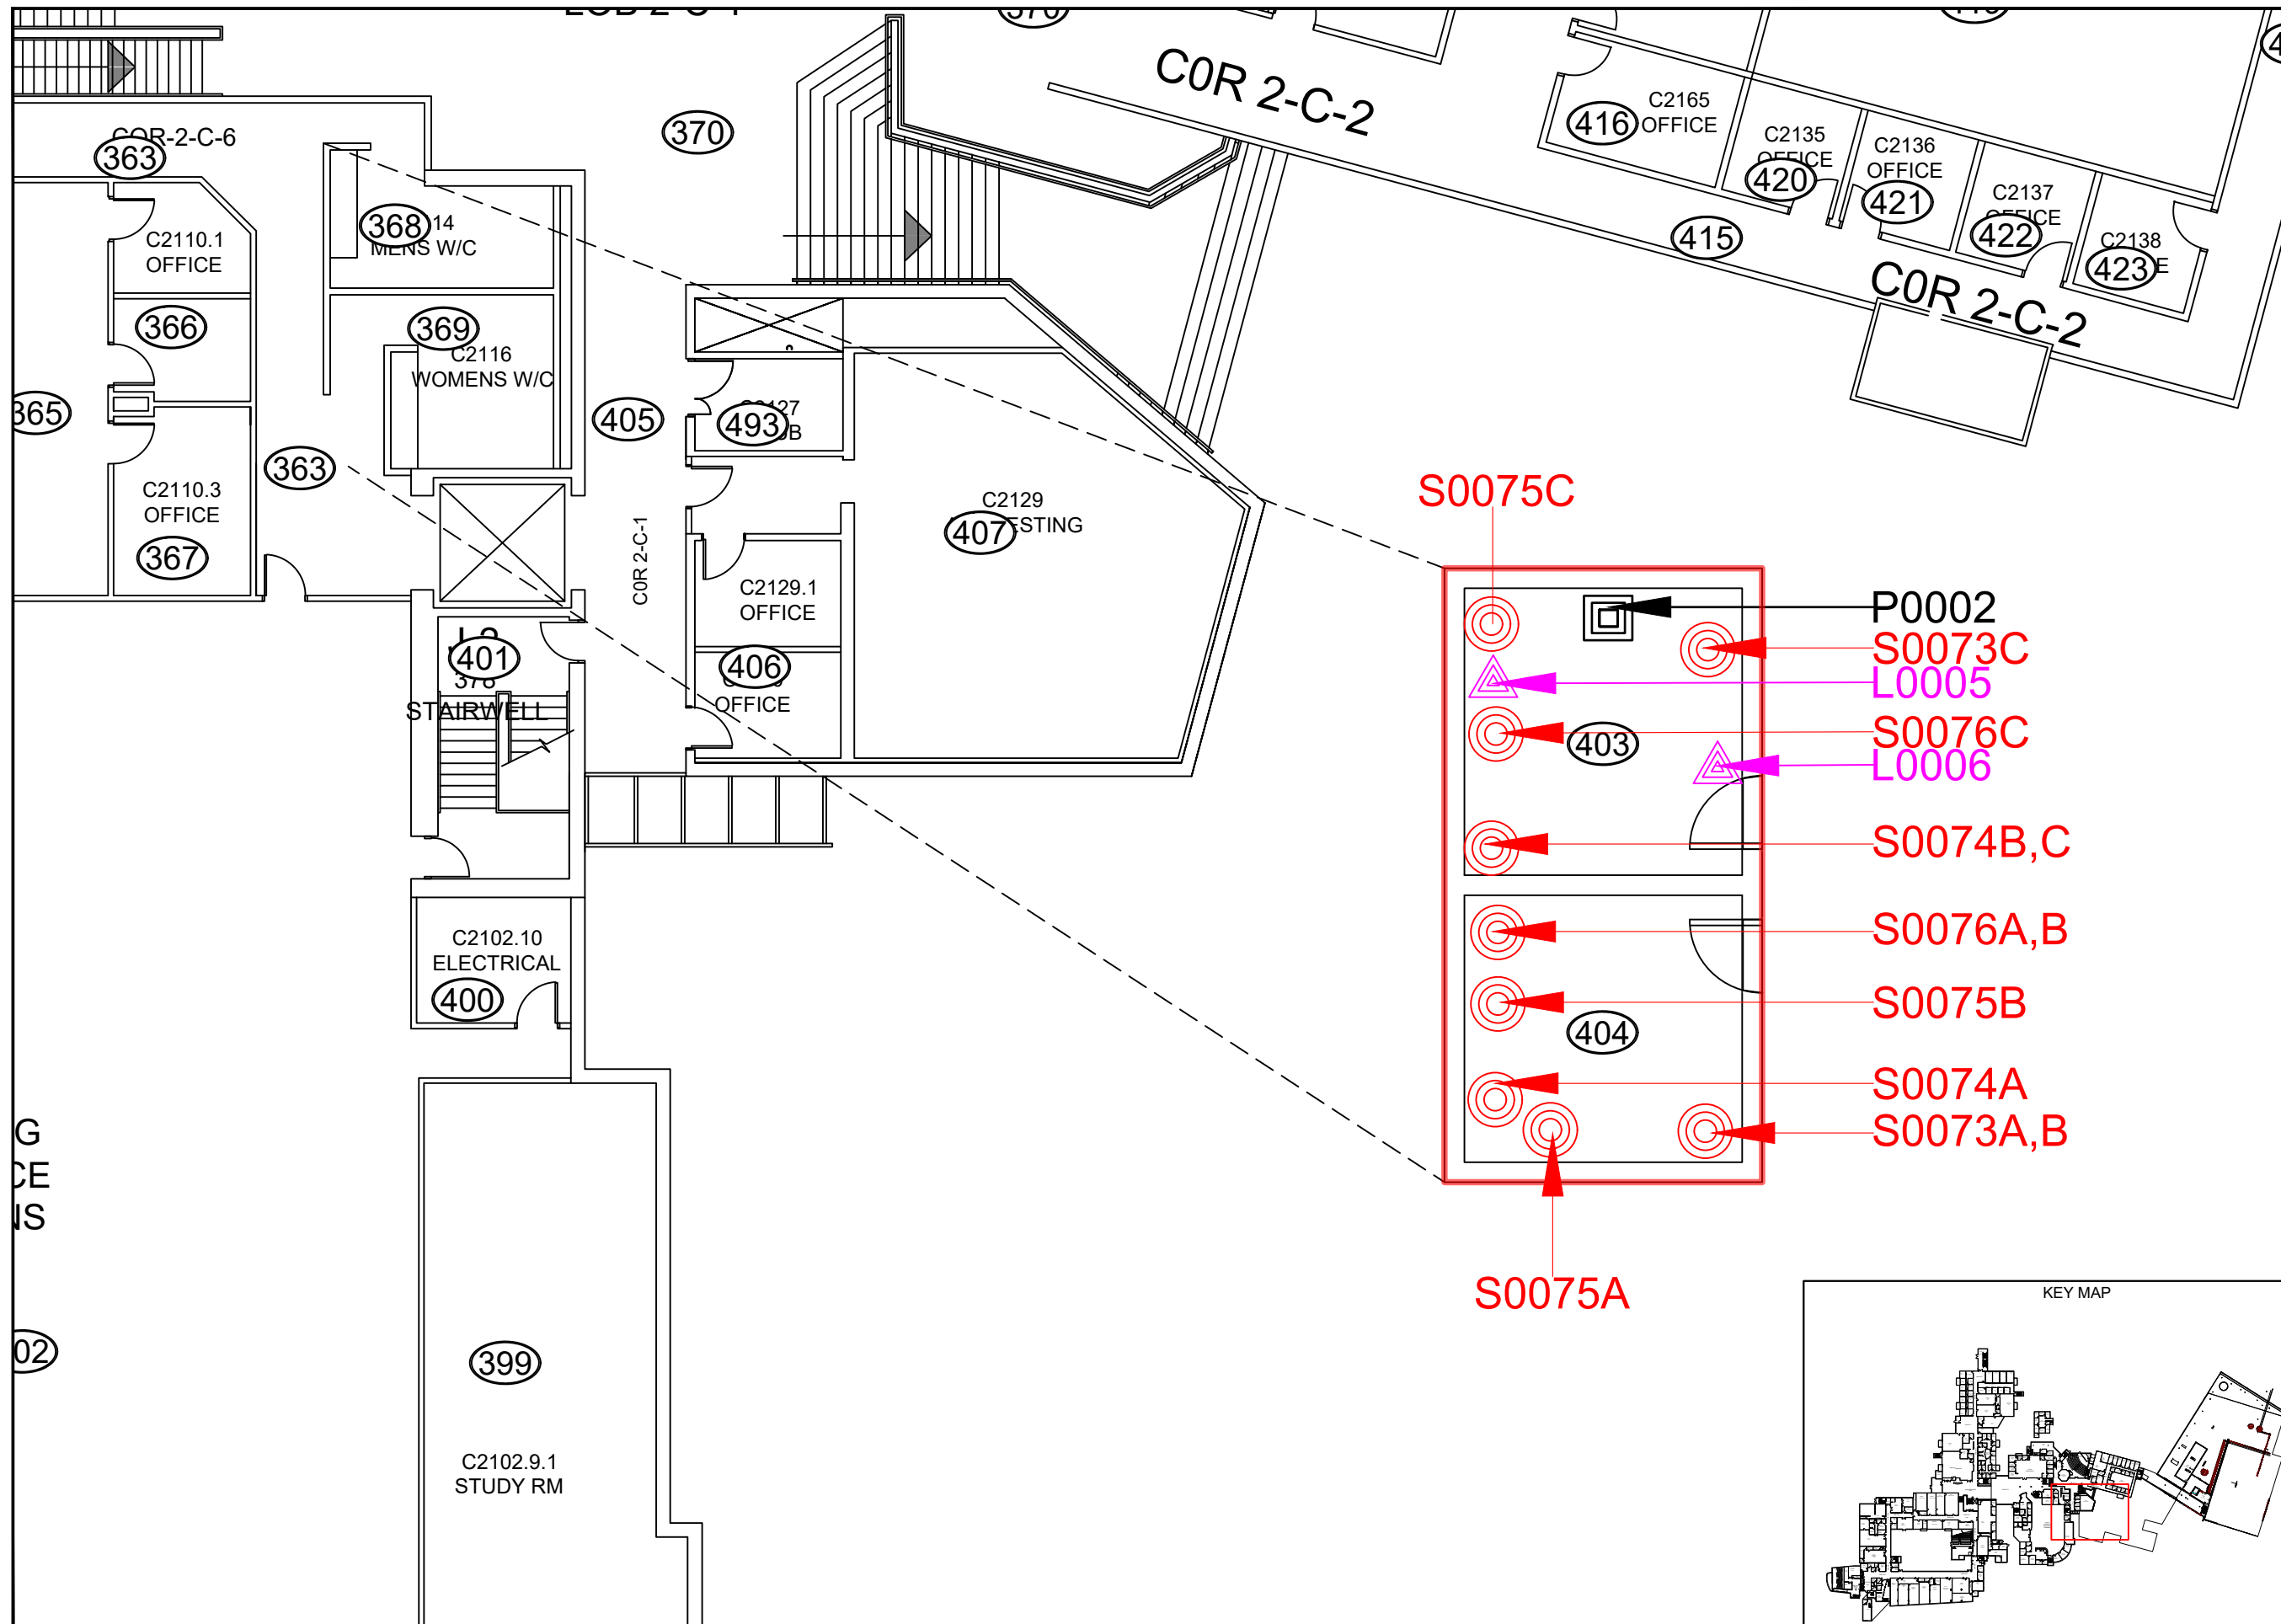
FIGURE NUMBER:
1 of 2

FOR CLARITY, THE FOLLOWING ASBESTOS-CONTAINING MATERIALS, ARE PRESENT IN THE ASSESSED AREA, BUT HAVE NOT BEEN HATCHED ON THE DRAWING:
